## **Restoration Opportunities for the Remnant Portions of the Lost Creeks of South Etobicoke**

Prepared by: Sarah Ariano, PhD Candidate, Ryerson University  
Department of Geography and Environmental Studies

Prepared for: TRCA and the City of Toronto

September 2020

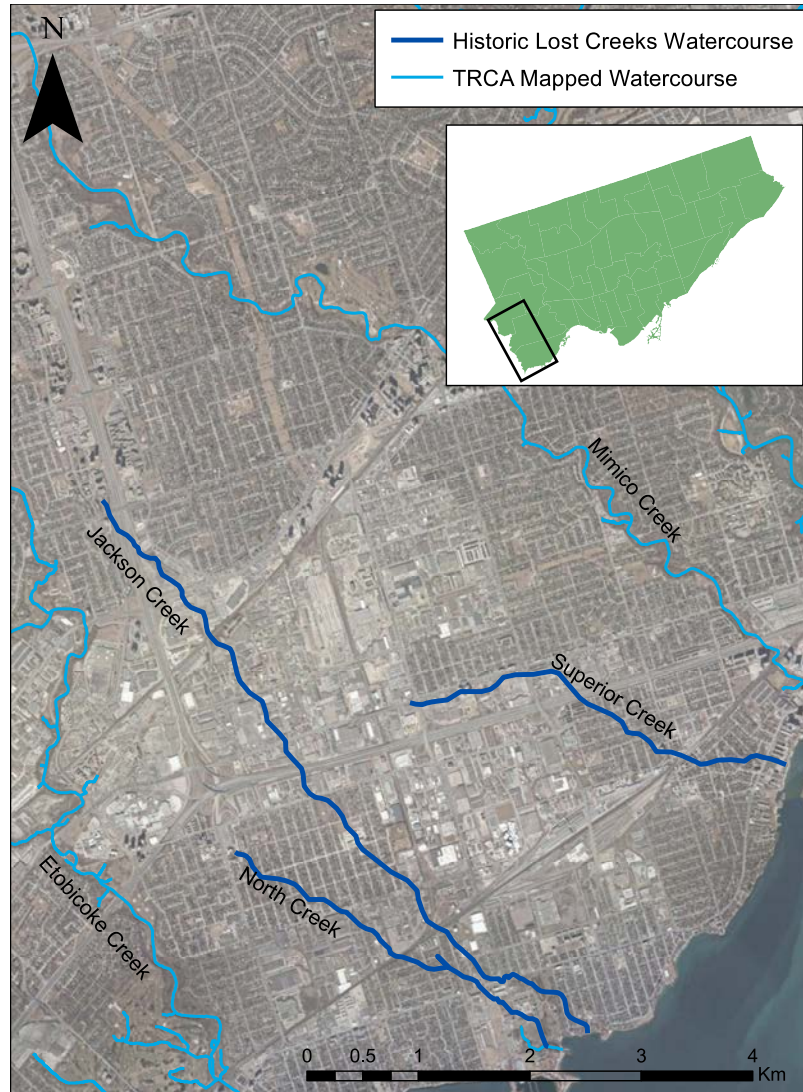
Figure 4: Study region, estimated historic Lost Creek watercourse, and current TRCA regulated watercourse, Toronto Ontario, Canada.

The study area is bounded by Etobicoke Creek to the west and Mimico Creek to the east, Bloor Street to the north and Lake Ontario to the south. The focus is three tributaries that originally drained directly into Lake Ontario: Jackson Creek, North Creek, and Superior Creek (Figure 4). Significant urbanization in the area has resulted in modifications to the natural watercourses for all three study creeks, including stream channelization, stream straightening and stream burial.

The watercourse of Jackson Creek was originally 7.1 km long. Currently the flow path of Jackson Creek is largely defined by swales, channelized and constrained channel and municipal stormwater drainage infrastructure. The total channel length of North Creek was originally 3.8 km long. The current flow path traverses a series of channelized or constrained swales, defined natural channels, and a wetland; however, significant portions of the creek are piped underground. The total channel length of Superior Creek originally spanned 5.1km. Currently, the entirety of Superior Creek is buried within the municipal stormwater drainage network and outlets at a stormwater outfall to Lake Ontario.

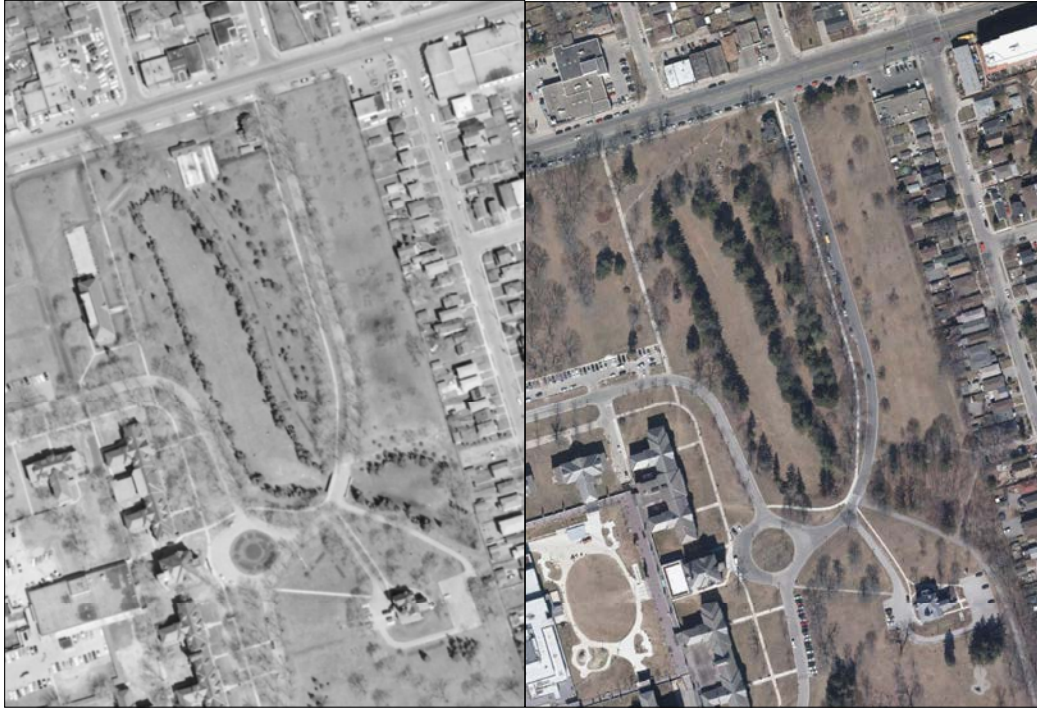
Figure 2: Grass swale at Humber College Lakeshore Campus, 1965 georeferenced aerial photography (left) and, 2019 orthophotography (right).

A large grass swale with catch basins and underdrain is located on Humber Collage Lakeshore campus (43.597534, -79.513218) (Figure 2). The creek was piped and the valley regraded about 1906 as part of improvements to the Mimico Asylum. The presence of catch basins are visible in the 1965 aerial photography and match the placement of present day infrastructure. Based on municipal stormwater data, this area does not appear to be connected to the stormwater mains. A detailed investigation of municipal stormwater connections should be conducted using dye tracer testing. Assessment of the City's GIS inventory and an analysis using LiDAR revealed that this area is dominated by localized drainage, representing an area of 0.069 Km<sup>2</sup>. This public property (TRCA IRP Viewer: <http://arcgis01.trca.on.ca/irp/>) is underutilized and would be an ideal site for a LID pilot project. This area could

be utilized for restoration opportunities, providing ecological (habitat), enhanced biogeochemical cycling (carbon and nitrate uptake) and community value, by improving this green space. Restoration options would need to be assessed after detailed inspection to determine the most appropriate design for end of pipe control. TRCA has included this site in its Restoration Opportunities database. This property is TRCA owned and managed by the City of Toronto.

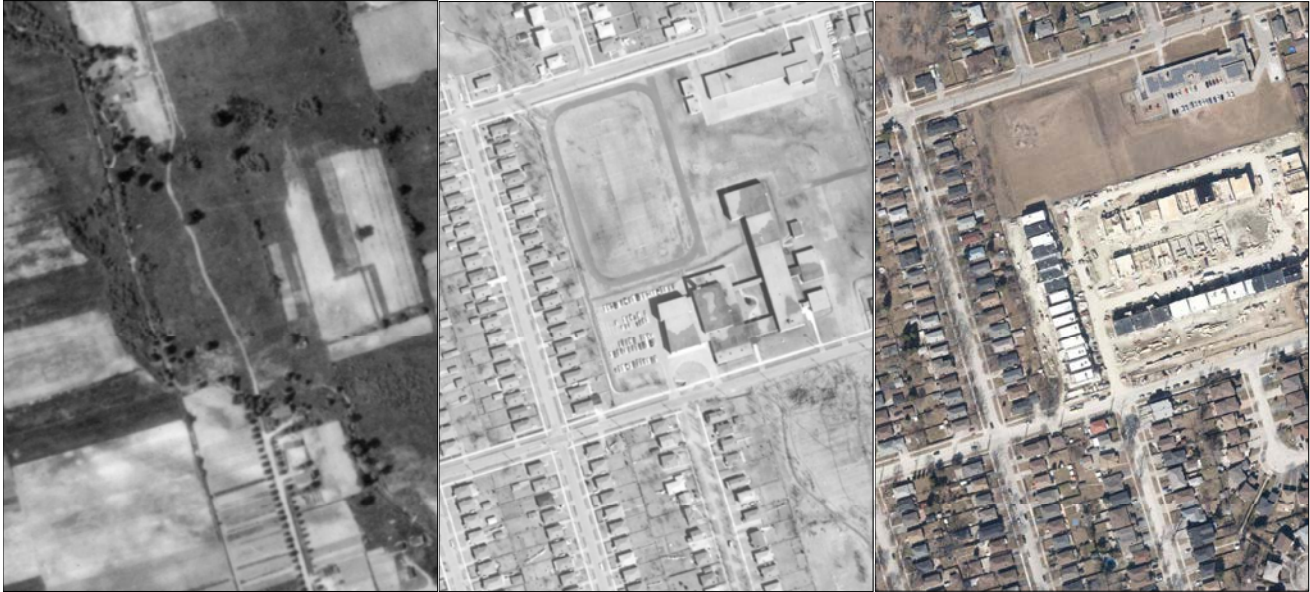
Figure 3: Jackson Creek at the former Father Redmond High School (former Alderwood Collegiate), 1939 georeferenced aerial photography, (left), 1965 georeferenced aerial photography (middle) and, 2019 orthophotography (right).

A housing development (43.609962, -79.533903) was constructed in 2017, replacing the old Father Redmond High School (former Alderwood Collegiate) and resulted in a missed opportunity to daylight Jackson Creek (Figure 3). This location remains an opportunity that should be flagged for a creek daylighting assessment in the event of redevelopment, or in the open-field portion just north of the recent townhome development.

1. The most notable loss occurred at the old Father Redmond High School (former Alderwood Collegiate), where the recent development of townhomes in 2017 resulted in a lost opportunity to daylight Jackson Creek. The redevelopment of this area could have been used to enhance City stormwater management, promoting infiltration through the use of a vegetated swale, reducing the impact of stormwater flow volumes on the City's infrastructure. In addition to hydrologic function, this opportunity would have provided ecosystem function and improved community value.

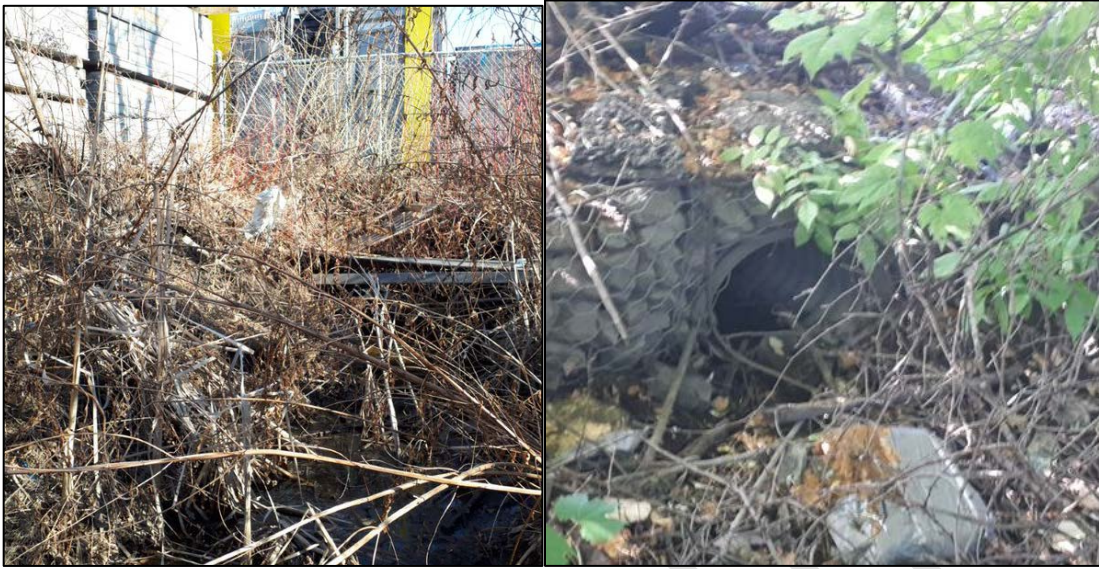
Figure 10: Drainage ditch on private property (Left), drains to privately owned pipe.

The remaining headwaters of Jackson Creek represent 0.025 km<sup>2</sup> of localized surface drainage on public and private land (Figure 9). The area drains to a private twin inlet catch basin that connects to the City's storm sewer through a stormwater pipe (Figure 10). The land use in the area is industrial (83%), institutional (<1%) and successional forest (16%), where 61% of the surface is impermeable. Based on the City's GIS inventory for stormwater assets, this water eventually flows to an outfall in Etobicoke Creek. According to the *Lost Creeks of Etobicoke Creek Watershed: A Headwater Drainage Feature Assessment Report* (2019) the headwater sites are located on public land (TRCA IRP Viewer: <http://arcgis01.trca.on.ca/irp/>) and underwent construction in 2019 which resulted in complete loss of the upstream headwater drainage features, however the stormwater ditch on private land remains.

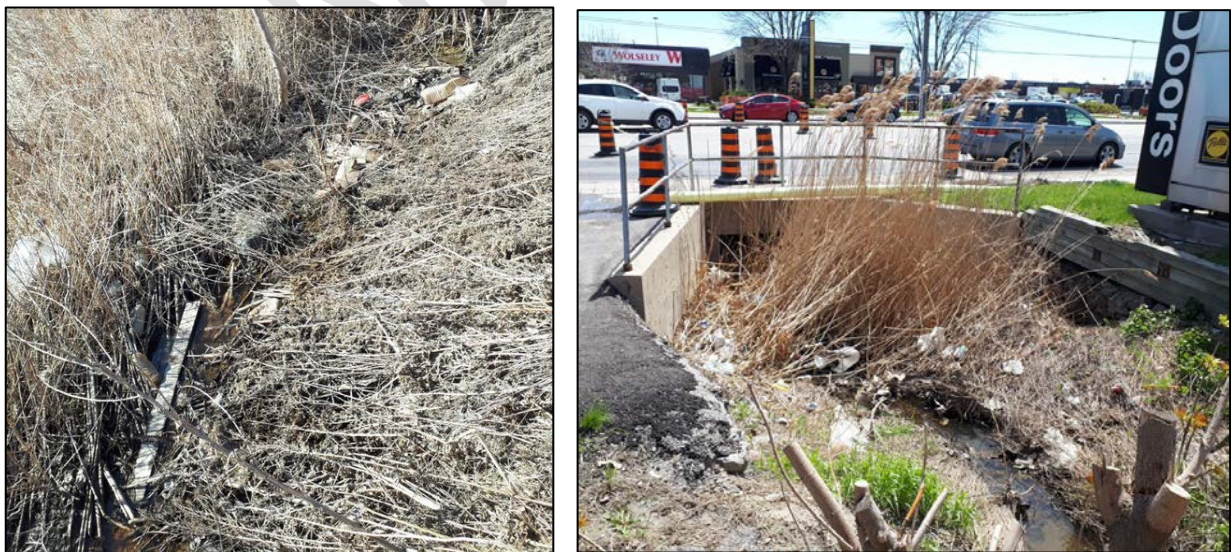
Figure 11: Drainage ditch on private property (Left), drains to a City of Toronto culvert with headwall (Right).

Drainage Area 2 (DA2) is 0.075 km<sup>2</sup>. This area is represented by 84% impervious surface and is dominated by a mix of commercial (33%), industrial (67%) with some road (<1%) surface drainage. The inlet location for DA2 downstream of the Jackson Creek headwaters is unknown. This area could include drainage from an outflow not recorded in the City's GIS inventory and regional private localized drainage determined by drainage area mapping (0.075 Km<sup>2</sup>) (Figure 9). This area drains to a City owned catch basin, inlet with headwall (Figure 11).

Based on the City's GIS inventory it is possible that drainage from this region is also segmented and flows to an outfall on Etobicoke Creek. However, a continuous flow pathway is also possible based on the presence of a large private outfall slightly downstream. A possible flow path into the City's storm sewers would need to be confirmed by inspection.

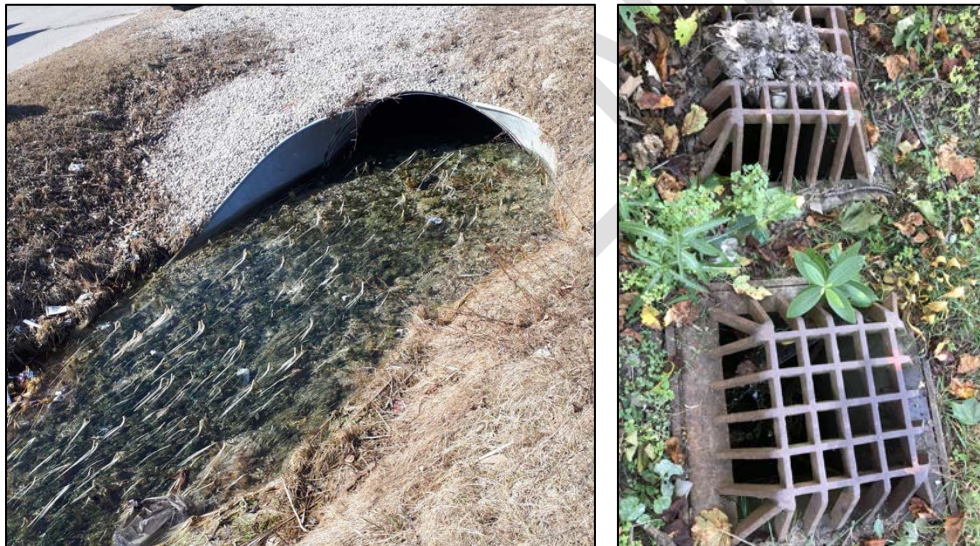
Figure 12: Private outfall (Left), drainage to downstream double beehive catch basin on private property.

Drainage Area 3 (DA3) is 0.093km<sup>2</sup>, where 82% of the surface is impervious. The land use in this area is represented by commercial (66%), industrial (23%), roads (7%), and recreation/open space (4%). The outfall for DA3 is not mapped in the City's GIS inventory and the upstream connections to DA2 are unclear. It is likely that a direct connection between the DA2 and DA3 exist, with the presence of an unmapped pipe, however further investigation is required to confirm this assumption. This area represents the second largest drainage area where portions of Jackson Creek remain above ground (0.093 Km<sup>2</sup>) (Figure 9). This remnant portion flows between two properties, to a double beehive catch basin (Figure 12). Two possible flow pathways are likely, the first is that a private pipe intersects laterally with a City owned storm water pipe and is transported to Etobicoke Creek. This is a suggested possibility due to GIS data indicating a pipe diameter increase from 1050mm to 1200mm without the presence of surface contributions along this stretch (no catch basins observed in GIS database). An alternative to this flow path is that the water flows downstream and enters a catch basin, which represents a ditch inlet for highway drainage. Site visits were unable to confirm if the drainage is daylighted before entering the highway ditch, as safety limitations prevented this investigation. The flow path of this drainage should also be confirmed through further investigation.

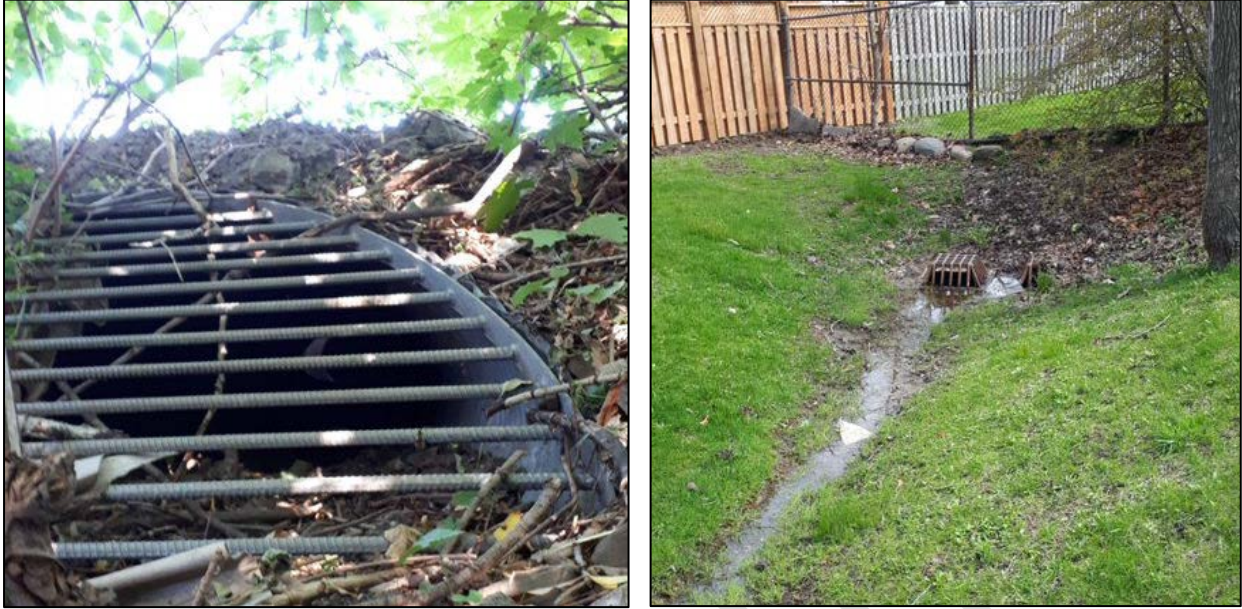
Figure 13: City of Toronto Outfall in Douglas Park (Left), drainage to downstream double beehive catch basin in Douglas Park (Right).

This flow path of Jackson Creek through Drainage Area 4 (DA4) is the best understood, with the creek flowing through a publicly owned drainage ditch in Douglas Park (TRCA IRP Viewer: <http://arcgis01.trca.on.ca/irp/>). The north end of the park has an active outfall without headwall (Figure 9). A conservative drainage area was determined to be 0.031 km<sup>2</sup>, excluding drainage from upstream DA1, DA2 and DA3, as the upstream flow path is unclear (Figure 13). This drainage area includes highway drainage and localized drainage from the nearby parkland. This area is dominated by 70% impervious surface with the majority of drainage attributed to the highway drainage. Roads (39%), industrial (30%), medium density recreation/open space (20%), residential (10%) and commercial (<1%), represent the land use. This area drains downstream to a double beehive catch basin in Douglas Park that is not mapped in the City's GIS inventory. It is assumed that a pipe connects with a downstream stormwater pipe and flows through the City's storm sewer to an outfall at Lake Ontario.

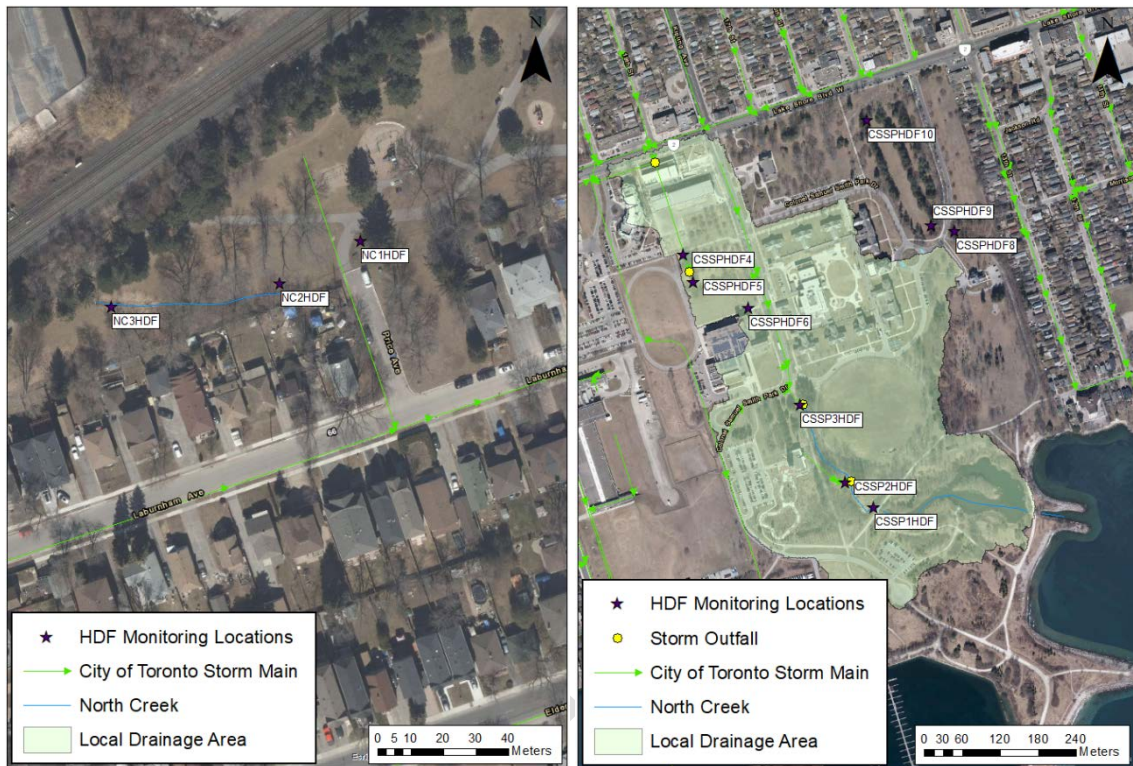
Figure 14: Remnant North Creek watercourse, potential sites for above ground restoration projects. Headwater (left) (DA5) and terminal wetland in Colonel Samuel Smith Park (right) (DA6).

The headwaters of North Creek include an outfall in Laburnham Park, City owned public land (TRCA IRP Viewer: <http://arcgis01.trca.on.ca/irp/>) that likely drains the upstream Canadian Pacific (CP) Rail property. The exact drainage area was unable to be mapped using LiDAR due to limited slope variability in the region (Figure 14). This area flows through the park incorporating localized park drainage (Figure 15). The ditch flows into the backyard of a private residence where the connection to the City's storm sewer network is unclear, but likely intersects one of two possible City's storm pipes downstream. This area likely drains to the same outfall at Lake Ontario as the DA4 and potentially DA3 sections of Jackson Creek.

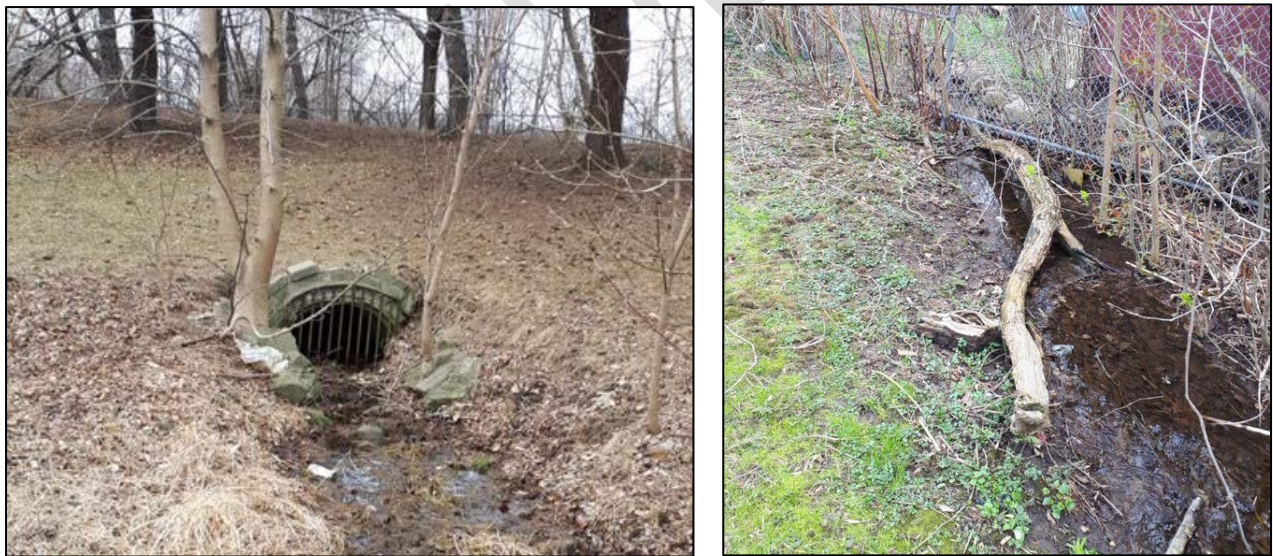
Figure 15: Outflow downstream of Canadian Pacific (CP) rail property (Left), drainage to private property, back yard (Right).

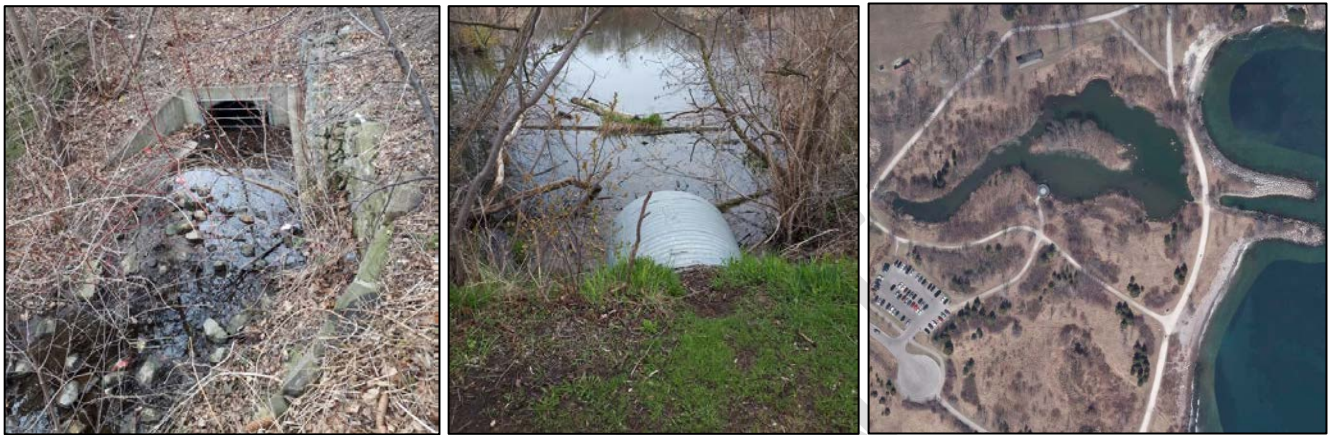
Figure 16: Left to right, Outfall to North Creek at Humber Collage, Outfall to North Creek Wetland, 2019, orthophotography of North Creek Wetland.

The terminal outlet of North Creek was originally Lake Ontario, however due to historic lake filling the North Creek wetland was constructed. This drainage area reflects localized drainage from the Humber Collage Lakeshore Campus and adjacent City park property - Colonel Samuel Smith Park (Figure 16). It is estimated that flow to an

outfall at Lake Ontario is more recent, and that prior to 2015, the upstream drainage of both North and Jackson Creek originally discharged aboveground on Humber College property, where the water meandered through the property and eventually drained to the North Creek Wetland through a currently abandoned pipe and outfall (Figure 14). The upstream drainage areas of North and Jackson Creek likely drain directly to Lake Ontario via an outfall and no longer drain through the North Creek wetland. The construction of a campus building between 2015 and 2016 likely resulted in the rerouting of this stormwater drainage, preventing flow through this pipe and outfall.
