Evaluation of shade balls for mitigating summer heating of stormwater management ponds

Final Report

Toronto and Region Conservation Authority

City of Brampton

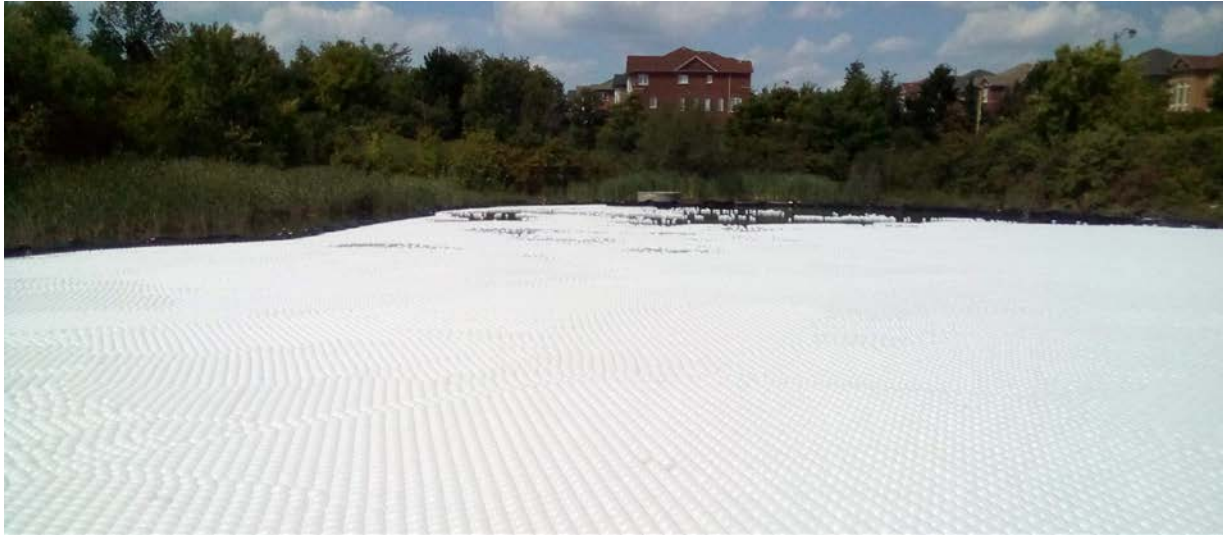
Figure 1: Esker Pond in Brampton, where shade balls were installed to provide 75% surface cover.

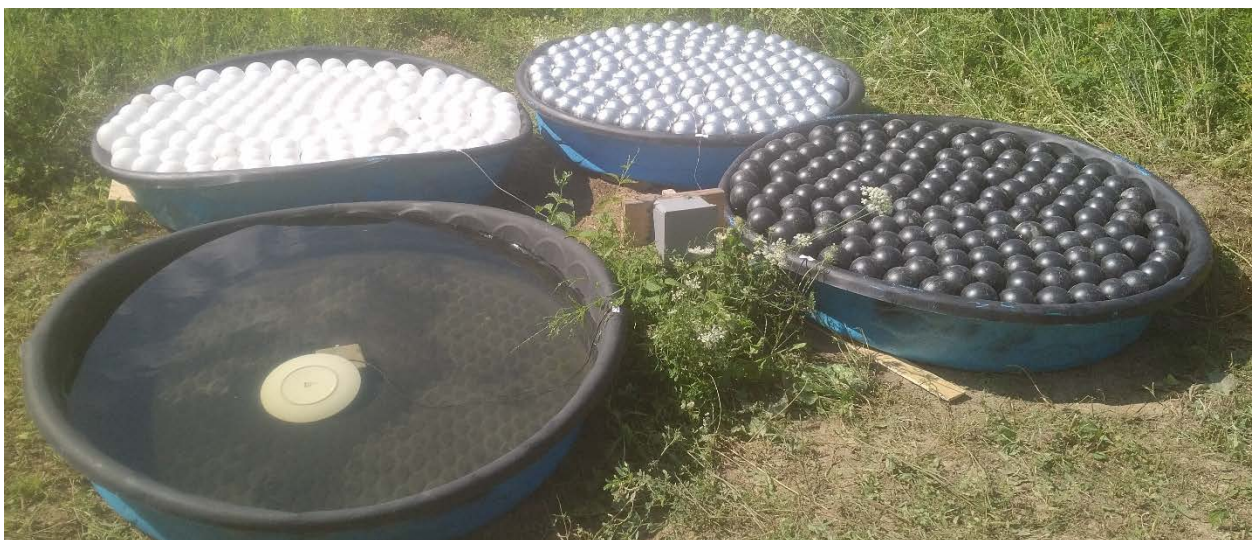
Separate small-scale testing of the balls was carried out using small wading pools which were placed in the photovoltaic field at the Kortright Centre for Conservation, located on Pine Valley Drive, just north of Rutherford Road in Vaughan. Testing at this site focused on understanding differences in shading performance between white, black and reflective paint-coated shade balls (Figure 2).

Figure 2: Small-scale testing to evaluate the effect of ball colour on cooling performance.

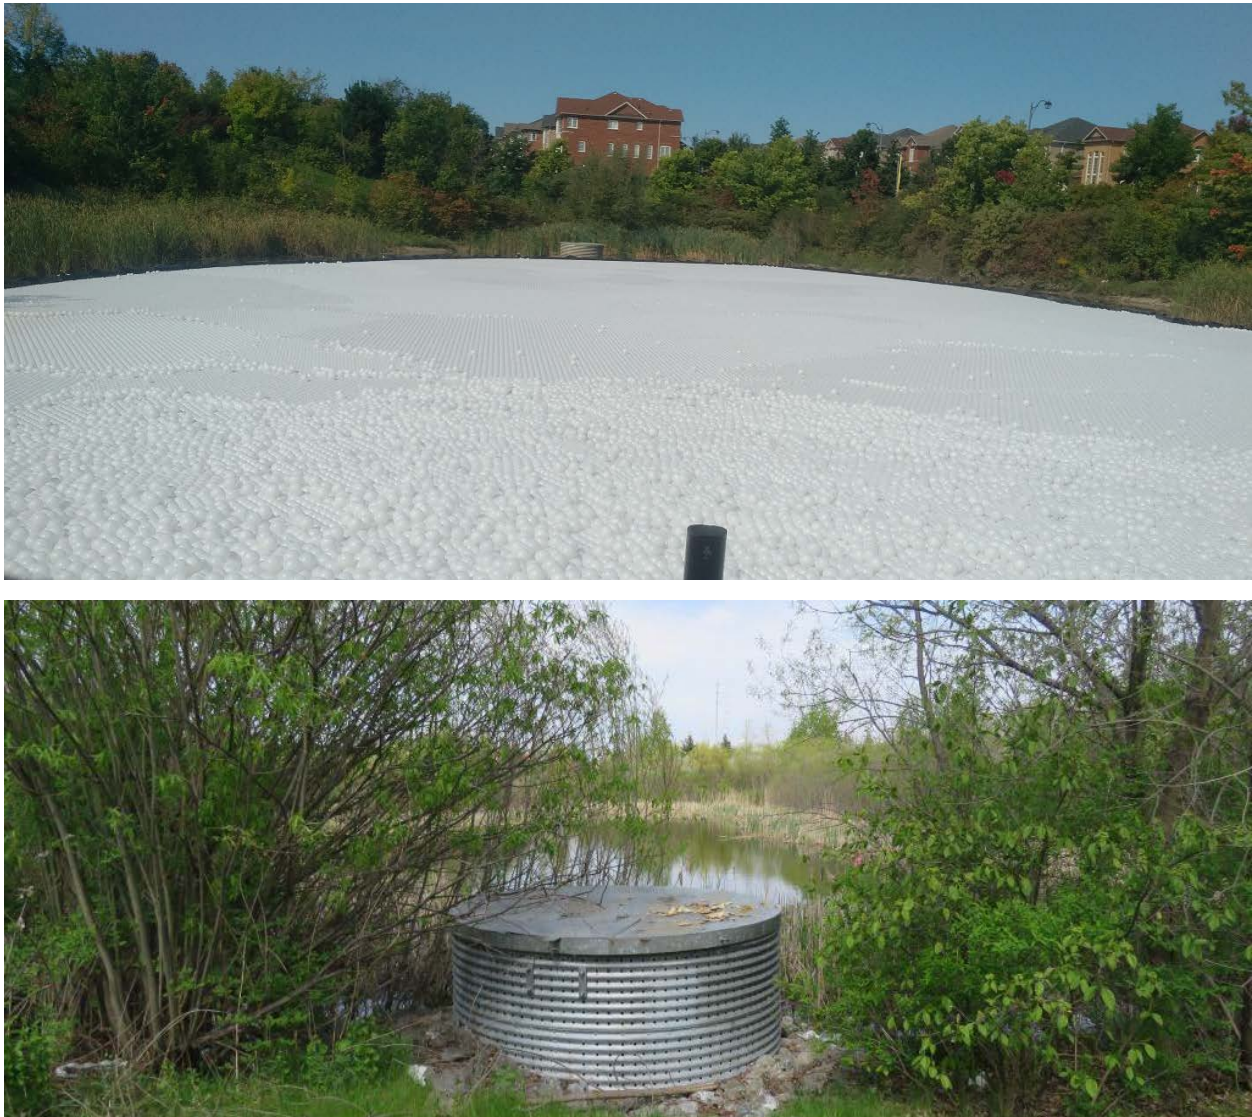
Figure 3.1: Shade balls pond (top) and control pond (bottom).

Two stormwater management ponds located in the City of Brampton were selected for thermal monitoring as part of this pilot study: one pond where shade balls would be deployed to cover 75% of the surface and one control pond (Figure 3.1). The shade balls were installed at a stormwater pond called Esker Pond, located near Moldovan Dr. and Father Tobin Rd. in the West Humber River subwatershed (Figure 3.2). The pond was selected due to its relatively small size, which made it suitable for a pilot test. Once deployed into the pond the balls remain in place year round and are not removed or replaced until the end of their lifespan.

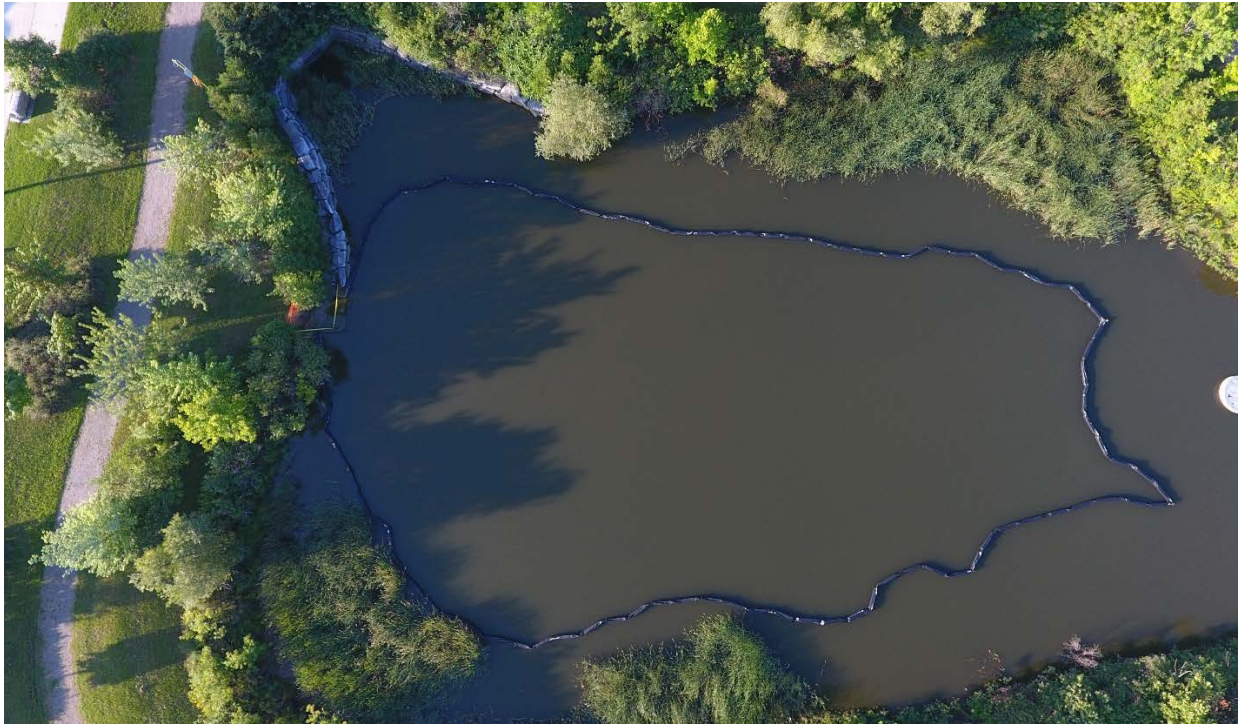
Installed within the shade ball pond was a barrier system (Figure 3.3) to hold in place the shade balls, which covered approximately 2000 m² - approximately 75% of the pond surface area. The barrier system, which keeps the balls in place, is a turbidity barrier consisting of geotextile fabric attached to a floating component at the water surface and an anchor component at the pond bottom. The float component extended 20 cm above the water surface to keep the balls in the enclosed area, while the anchor component consisted of chain and cinderblocks. The barrier was installed in a total of 10 sections, each having dimensions of 0.9 m by 15.2 m.

Figure 3.3: Barrier system in place before shade balls were deployed into the pond

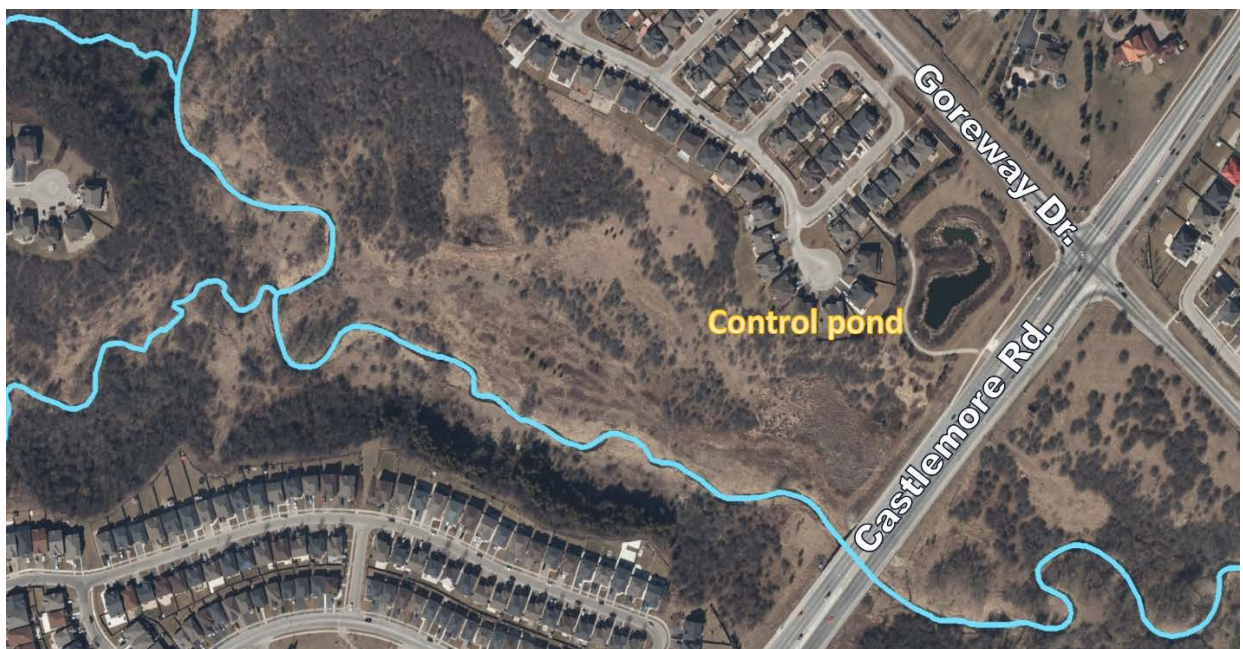
Figure 3.4: Location of control pond

The control pond selected for the study (Figure 3.4) is similar to the shade ball pond in size, located in the same subwatershed, and has a contributing drainage area that is similar with respect to land use. Design parameters of both ponds and characteristics of their contributing drainage areas are summarized in Table 3.1.

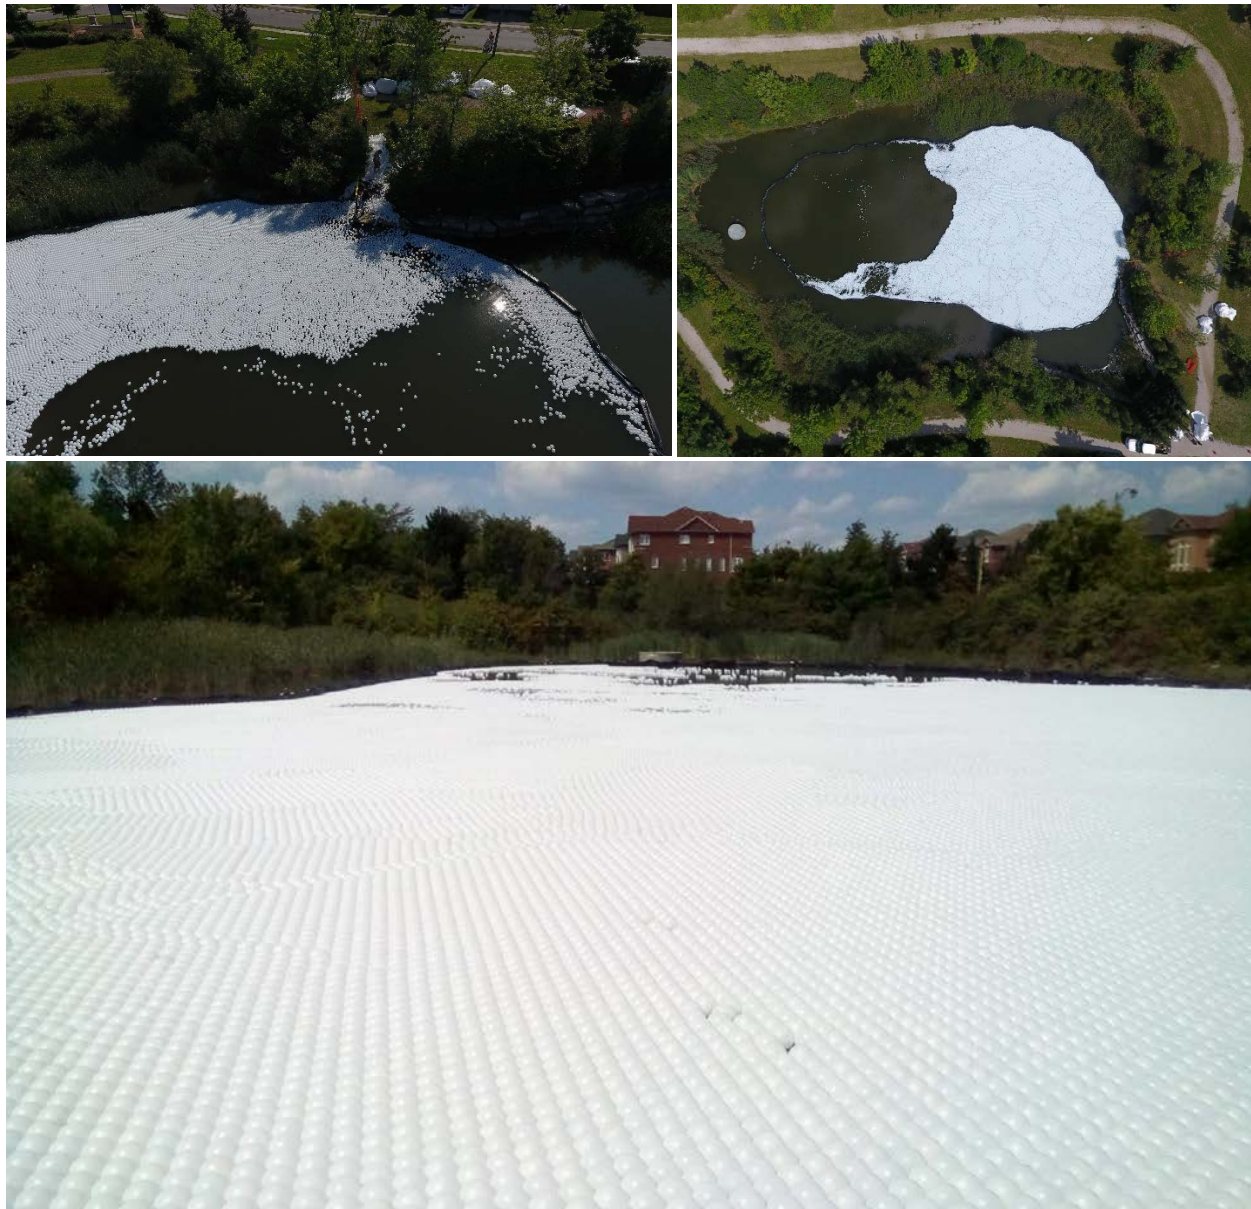
Monitoring of baseline temperatures and outlet water levels at the shade ball pond in Brampton was initiated in June 2018 and continued until shade balls were deployed into the pond in late August 2018. The balls were shipped and deployed into the pond (Figure 4.1) on two different dates - first on August 24, 2018, which resulted in pond surface area coverage of roughly 40%, and second on September 18, 2018, which covered the remaining 35% area to achieve the planned shading of 75%.

Figure 4.1: Installation of shade balls in August 2018.

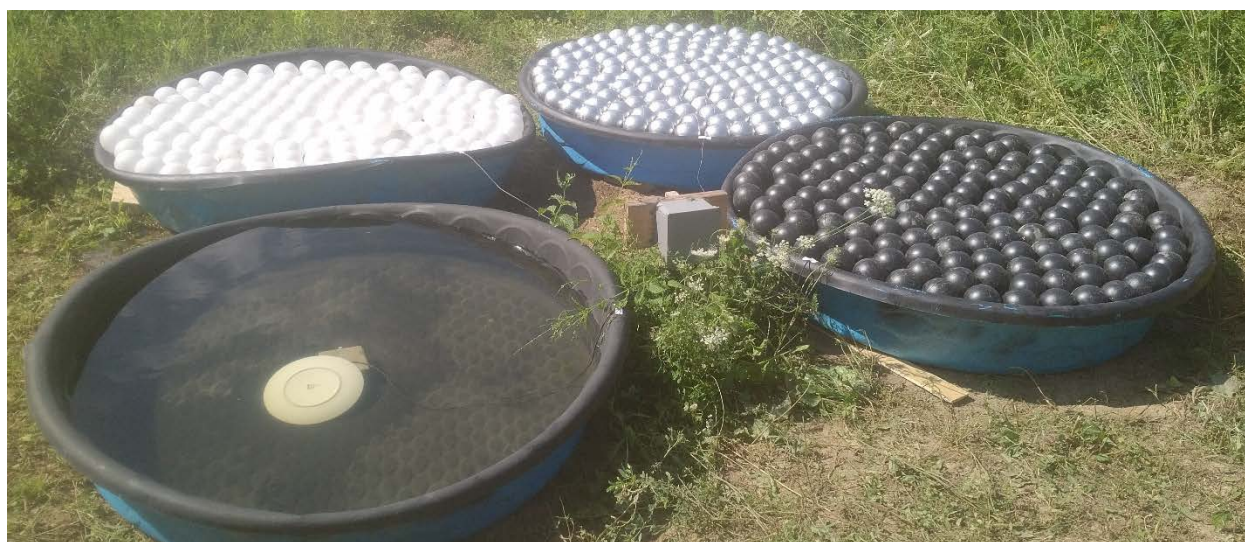
Four small circular wading pools, each 1.3 m in diameter, were used to simulate stormwater management ponds in four different scenarios: (i) white ball coverage, (ii) silver reflective ball coverage, (iii) black ball coverage, and (iv) no ball coverage. The pools were placed on the ground at the Kortright Centre for Conservation photovoltaic field (Figure 4.5), which was selected as the experiment location because it’s a large, open area free of structures that could cast shadows over the pools and is gated to prevent public access. Before the wading pools were set up, the area was landscaped to remove any large weeds and grass and levelled out to ensure the pools would sit on a flat surface. Each pool was filled with tap water to a depth of 23 cm, and except for the control, 150 shade balls.

Figure 4.5: Wading pools at the small-scale shade ball testing site

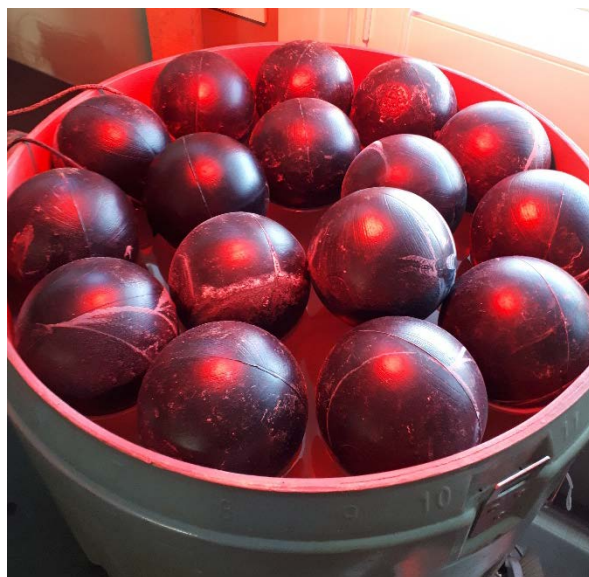
The test was conducted inside the Archetype Sustainable House at the Kortright Centre for Conservation in November 2019. Three empty ISCO water sampler carousels - each 50 cm in diameter - were used to hold the three differently coloured balls. The sampler carousels were filled with tap water to a depth of approximately 20 cm and then 16 balls were added to each to cover the water surface. A heat lamp was positioned above the balls and their surface temperatures were measured using a handheld TiR FLUKE Thermal Imager. In each of the three sampler carousels, a HOBOW smart temperature sensor was inserted into one of the balls to measure the temperature increase inside the ball. Smart temperature sensors were also placed at the bottom of the sampler carousels.

Figure 4.6: Heating black shade balls with a heat lamp during experiment

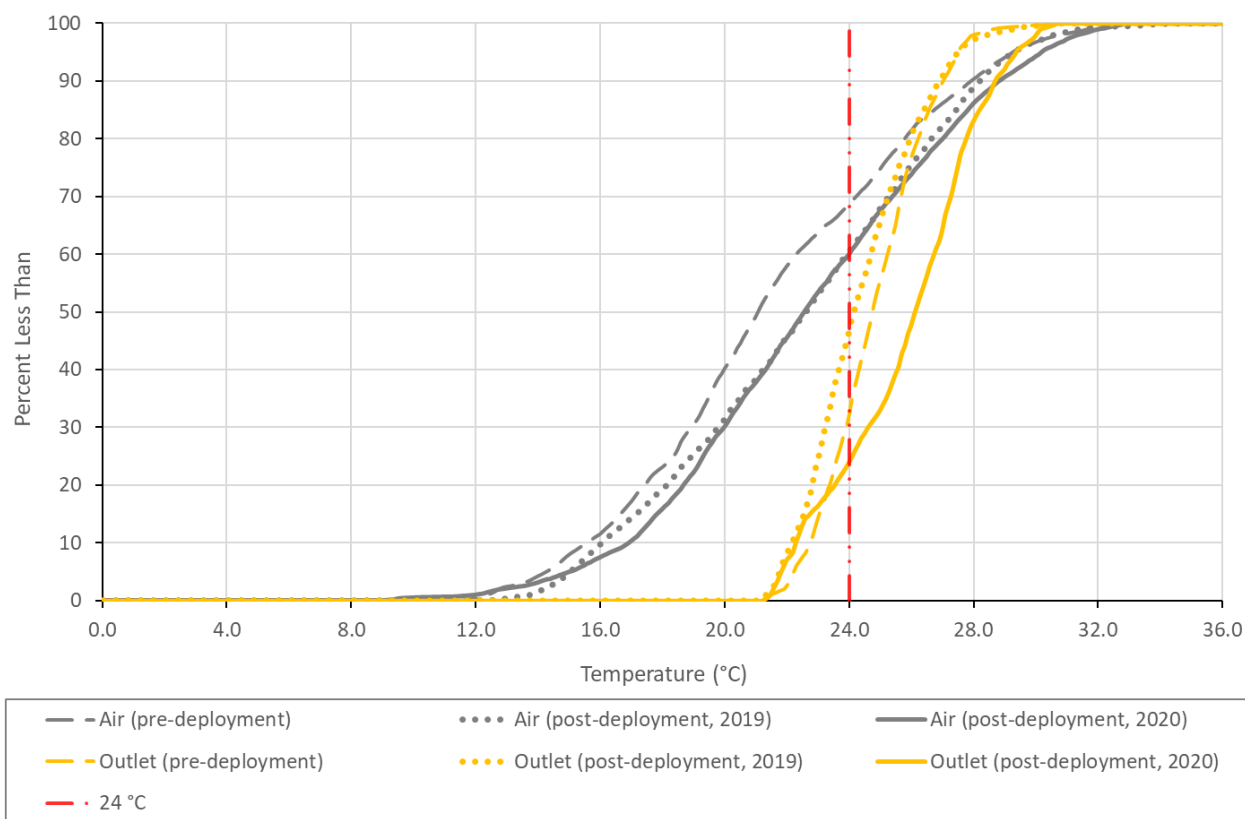
Within this larger data set (July 13 – August 24) outlet temperatures were cooler overall and there was a reversal of the trend noted for 2018 and 2019 in Figure 5.2. While air temperatures were coolest in 2018, outlet temperatures did not follow this trend; median outlet temperatures were 0.7 °C cooler in 2019 relative to 2018. The slightly cooler outflow temperatures observed in 2019 could be interpreted as a cooling effect attributable to the shade balls, however the same trend was not observed in 2020, during which air temperatures were similar to 2019, but median and average outflow temperatures were 2 °C and 1.5 °C higher, respectively.

With respect to meeting the 24 °C threshold, most outlet temperature measurements were in exceedance for all three years, with 68%, 54% and 76% of measurements exceeding the threshold in 2018, 2019 and 2020 respectively.

Figure 5.3: Comparison of ball pond outlet temperatures during July 13 to Aug. 24 of each year.

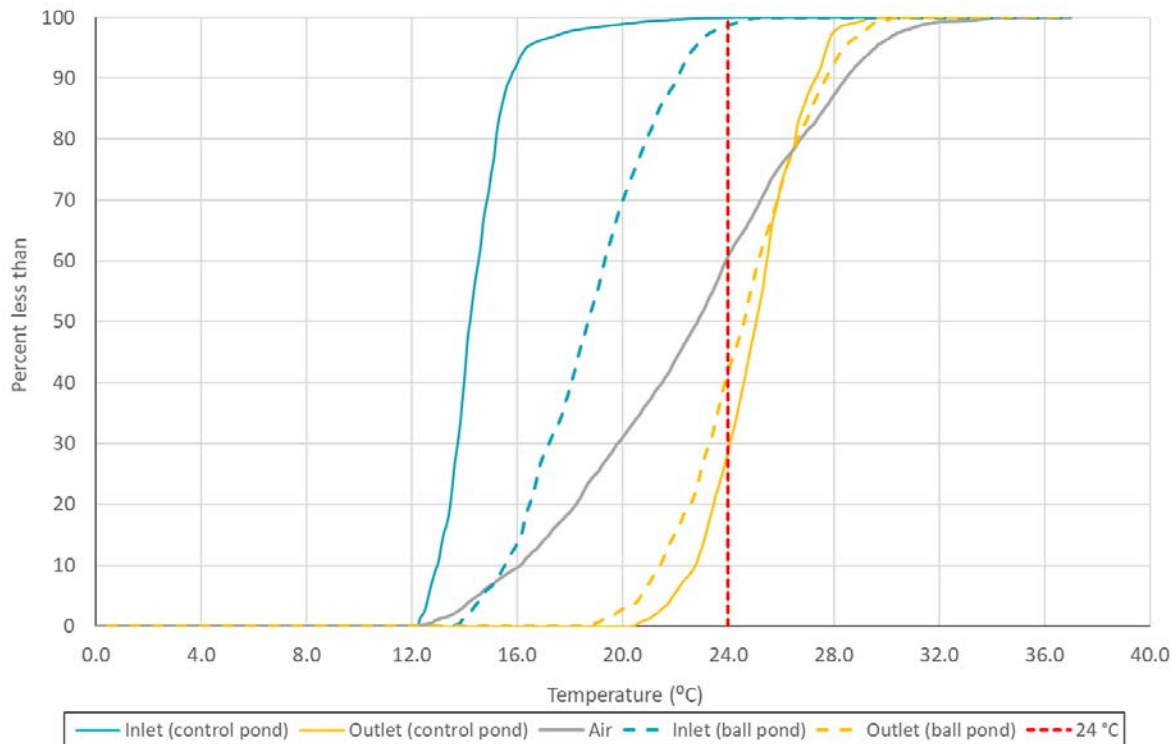
Figure 5.5: Comparison of temperature frequency curves for control and ball ponds in 2019. Based on temperature data collected between June 19 and July 24, 2019.

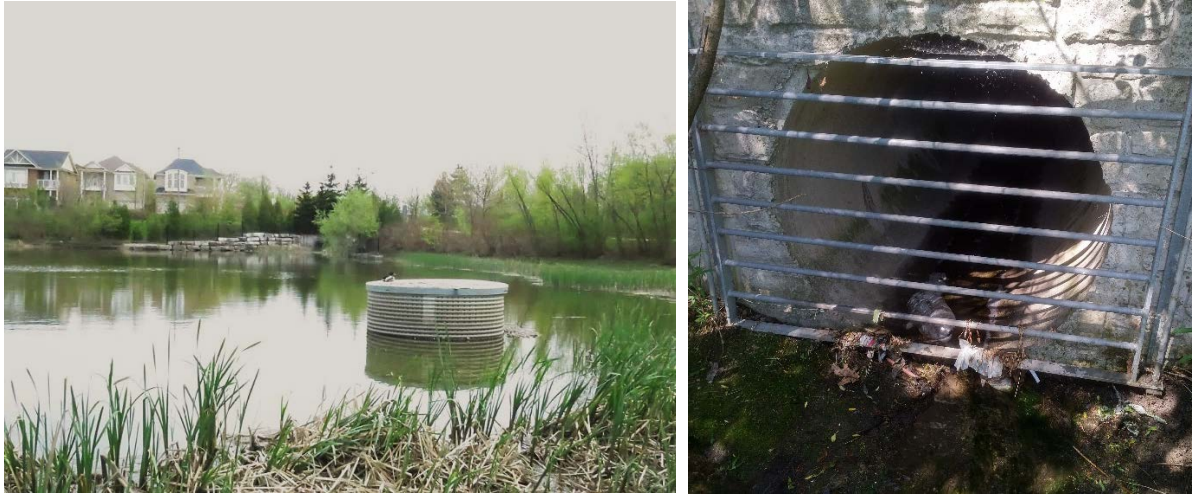
Figure 5.7: Control pond (left) and control pond inlet (right).

Relative to the ball pond, the control pond caused a greater degree of warming during all years. Median increases from inlet to outlet ranged from 6.6 to 11.4 °C at the control pond and only 3.1 to 5.9 °C at the ball pond. This cannot necessarily be considered indicative of a cooling effect of shading at the ball pond relative to the control. As described in section 5.1.1, warming from inlet to outlet at the ball pond did not decrease after the shade balls were installed, but rather the ball pond caused less warming prior to their installation (2018) than it did in the two subsequent years. The higher magnitude of warming at the control pond could be mainly a consequence of its cooler inflows. While water starts off cooler coming into the control pond, outflow temperatures at the control and ball ponds end up similar because warming plateaus at a point that is mainly dictated by local air temperatures, precipitation events and pond detention times.

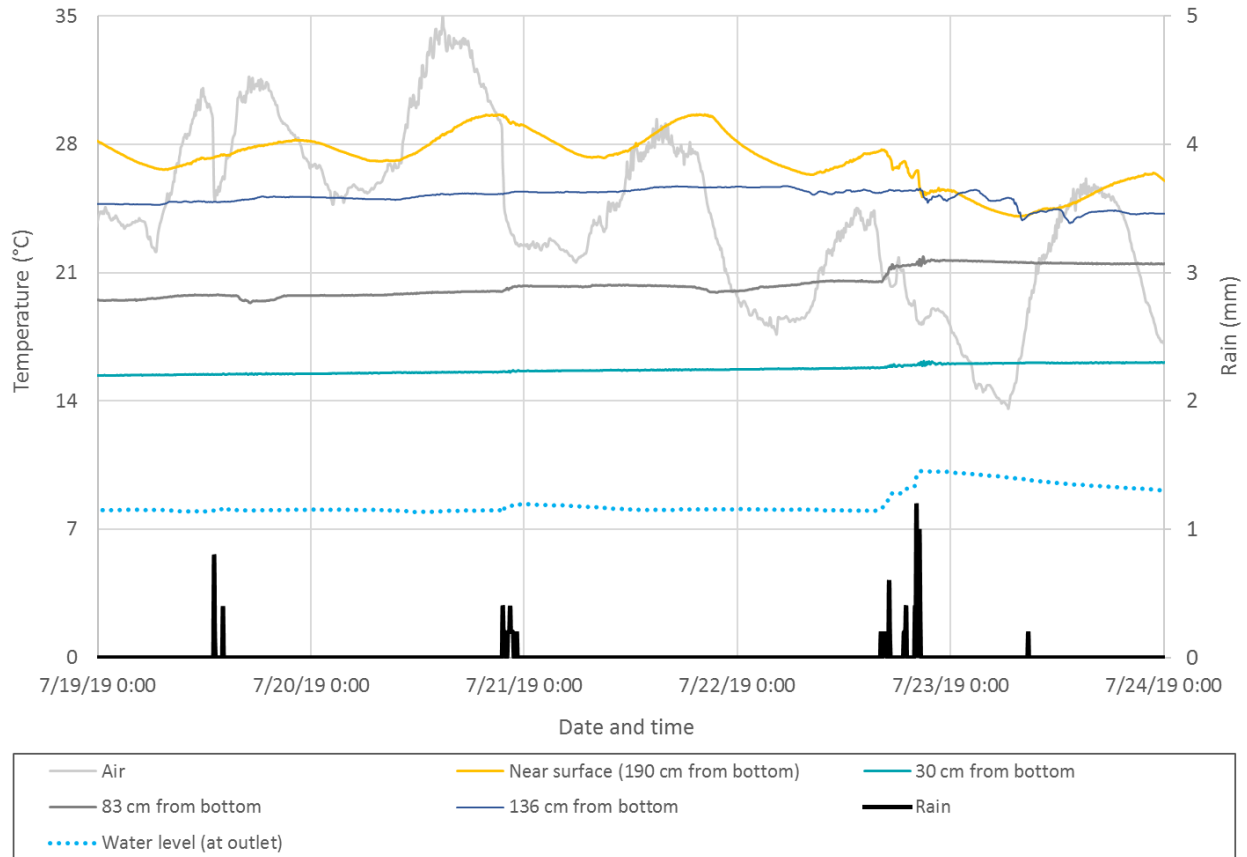
To better understand whether the barrier system was altering the flow path and creating a cooler zone under the balls that was not being pushed through to the outlet, the temperature profile was analysed during several small rainfall events in July 2019, the largest of which occurred on July 22 and showed a corresponding increase in water level (Figure 5.10). The chart shows that incoming flows from the 7 mm rainfall event did in fact cause water to mix in the ball containment area, affecting the two top sensors in the profile (down to 136 cm above pond bottom). Temperatures recorded at those two top sensors were overlapping, the stratification that previously existed being eliminated as water flowed through the pond during the event. The lower part of the profile was much less affected by the inflow of water, with the sensor at 86 cm showing a small warming of approximately 1°C during the event, and the lowest sensor (at 30 cm) showing no significant warming.

This observation suggests that the much cooler water found near the pond bottom beneath the shade ball containment area was not being pushed through the pond to the outlet during rainfall events. If the ball barrier system was impeding flow through to some extent, this could explain why the full cooling effect of the shade balls, which seems to be evident in the profile data, is not translating into a significantly cooler pond outflow.

Figure 5.10: Temperature depth profile of shade ball pond during a 7 mm rain event on July 22, 2019.

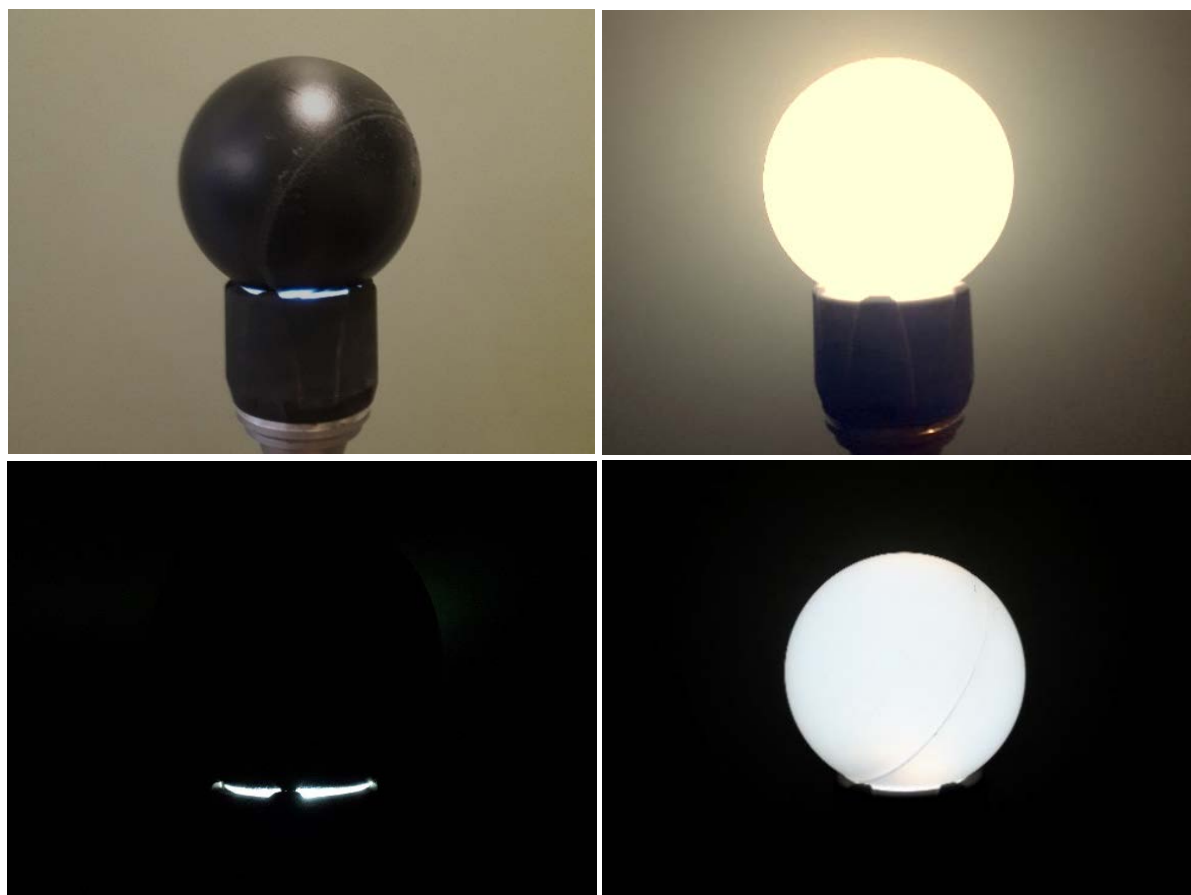
Figure 5.18: Illumination of a white shade ball (right) vs. a black shade ball (left). Pictures on the top row were taken with lights on, pictures on bottom row were taken in the dark.

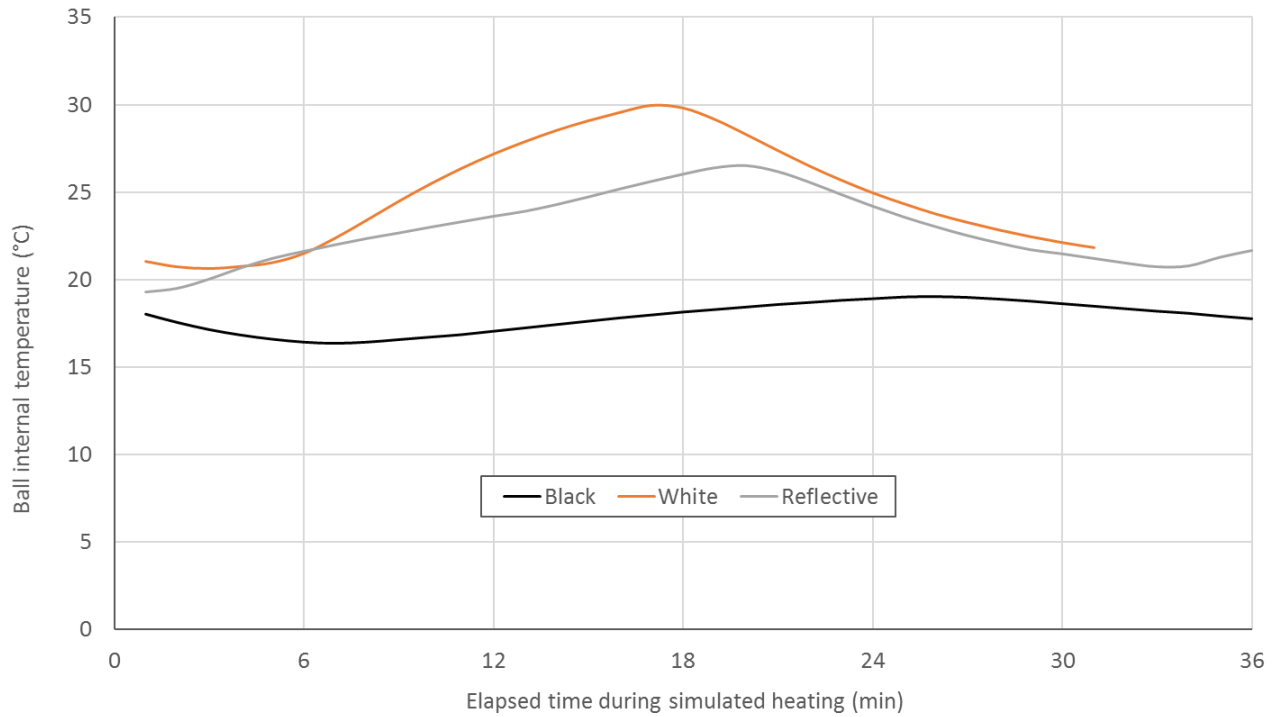
Figure 5.19: Internal temperature of black, white and reflective balls as measured during heating with a heat lamp

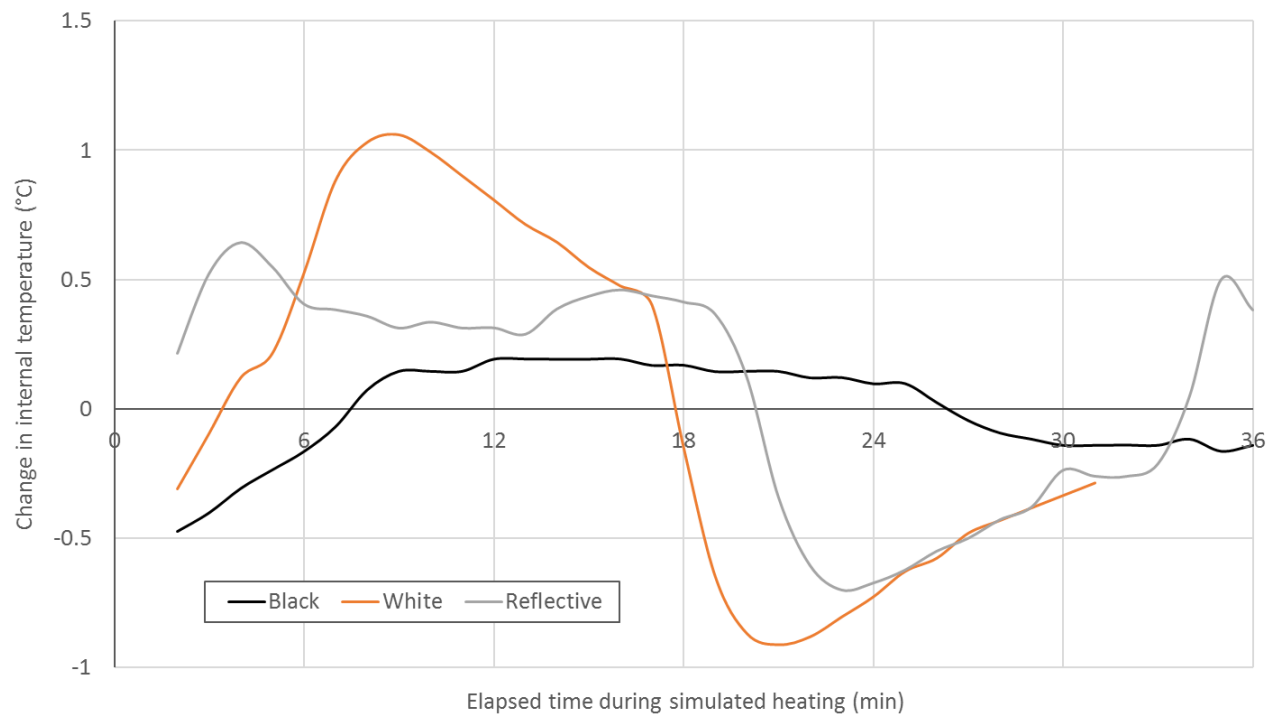
Figure 5.20: Change in internal temperature of black, white and reflective balls following heating

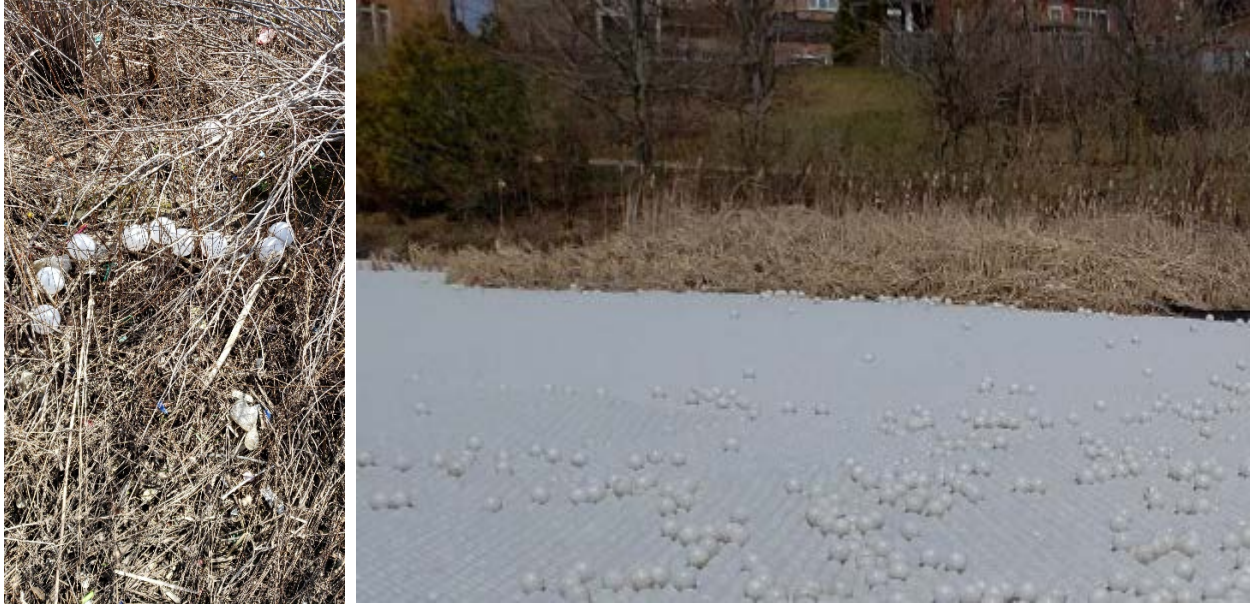
In practice, some unanticipated maintenance needs were observed over the course of monitoring at the shade ball pond. Several shade balls were blown out of the ball containment area and into vegetated areas around the pond, from which they had to be removed (Figure 5.22). Suppliers of the balls do note that strong winds can sometimes cause shade balls to be blown away. The balls may also be more susceptible to wind displacement during the winter when the pond is frozen, as the ice causes a heave effect that results in balls sitting higher than their normal level relative to the barrier. An additional factor that could contribute to ball displacement is the growth of emergent vegetation, which was observed in the shade ball containment area (Figure 5.22). Suppliers suggest that where shade balls are at risk of wind displacement, there is the option to weight the balls by half filling them with water (Layfield, 2019). Alternatively, a taller barrier around the ball containment area or fencing around the pond could be installed to keep the balls from blowing away.

Figure 5.22: Shade ball displacement issues observed, including balls blown into surrounding areas (left) and emergent vegetation growing into the ball containment area (right).
