IMAX Low Impact Development Feature Performance Assessment

Prepared by:
Credit Valley Conservation

February 2022

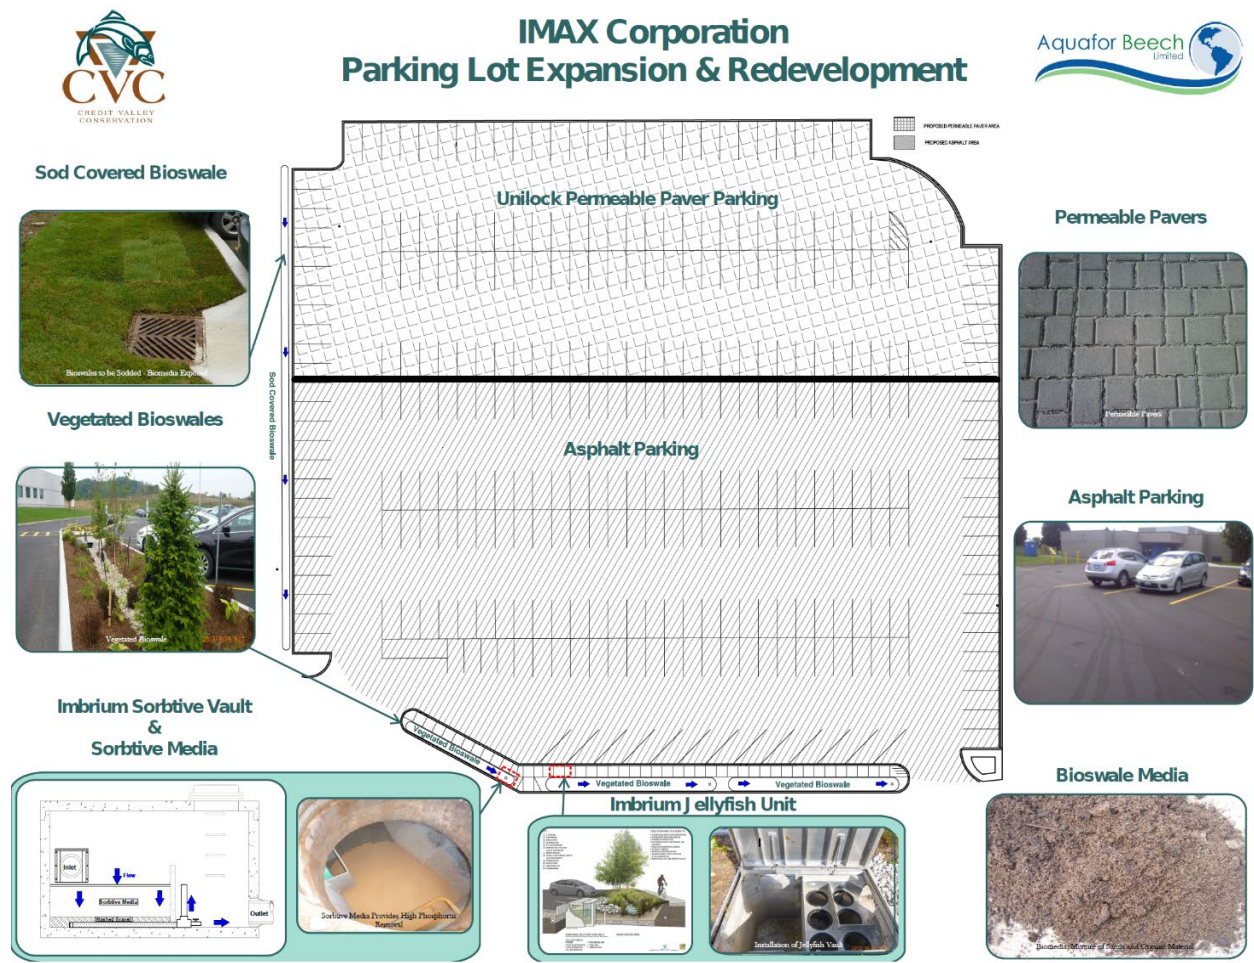
Figure 2: IMAX retrofit design concept.

The total drainage area for the site is 1.0 ha (9,978 m²) based on 2014 as-built survey results. The IMAX parking lot retrofit applies LID features which were customized to suit local hydrological and geological conditions. The layout of the parking lot, and locations of different LID features, is shown in Figure 2. The main source of runoff to the LID features is from the parking lot and entrance driveways. Permeable pavement was installed in the northern portion of the parking lot, however due to a low depth to bedrock, bioretention systems were installed along the southern and eastern edges to receive runoff from asphalt in the southern portion.

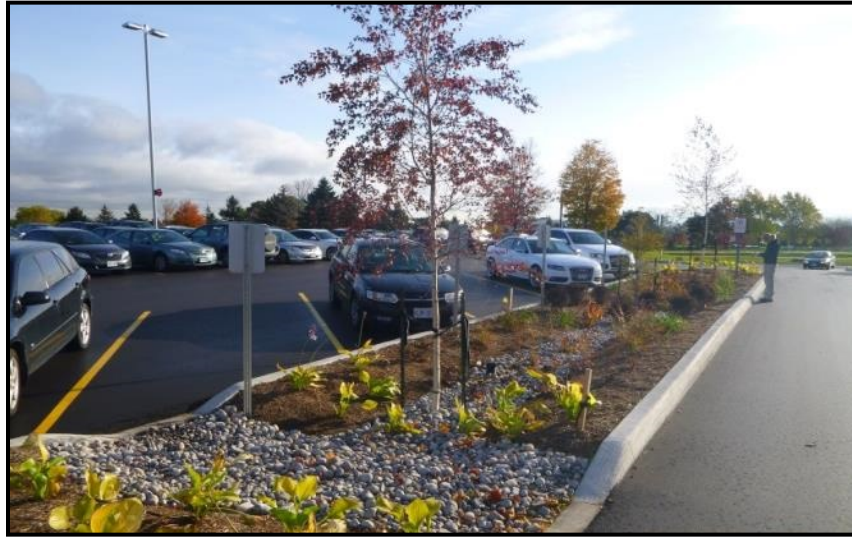
Figure 3: Bioretention swale at IMAX looking downstream.

Bioretention swales are engineered soil/media filter systems that temporarily store and filter stormwater runoff. Three side-by-side bioretention practices were integrated into the front of the parking lot retrofit to improve runoff water quality; each system has its own perforated underdrain and outlet monitoring location (Figure 3).

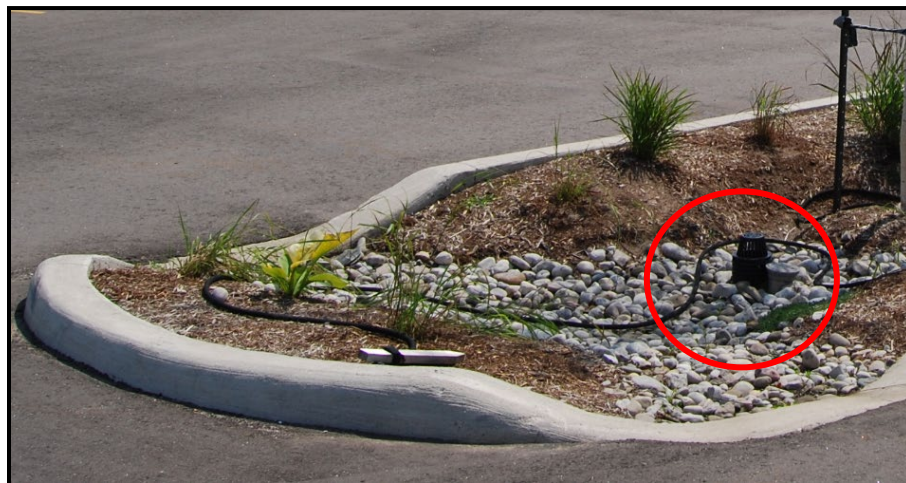
Figure 4: Inlets to one bioretention swale, and an overflow drain circled in red.

The bioretention swales accept overland sheet flow from their designated parking lot drainage area. Inlets to each of the three swales consist of a simple curb cut (Figure 4).

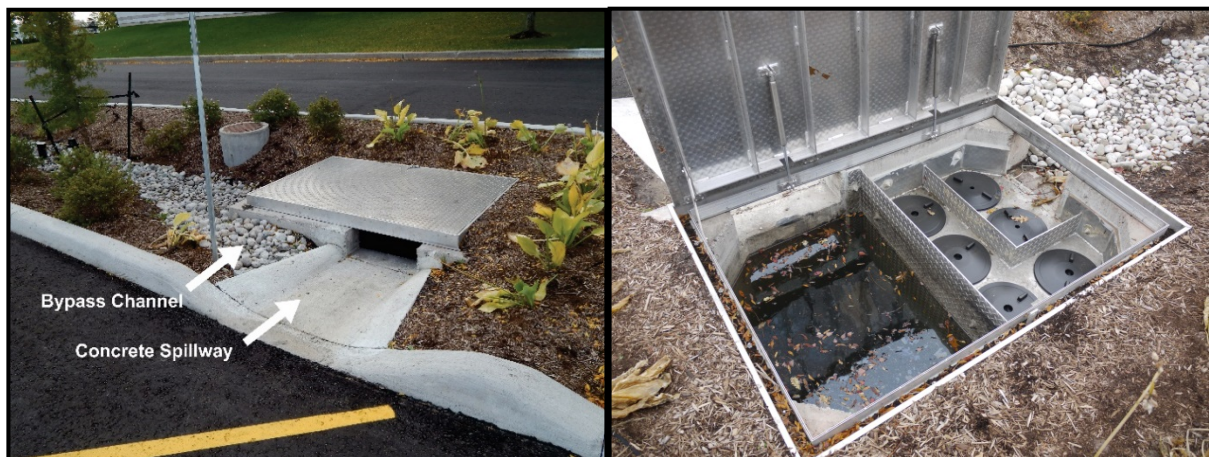
Figure 6: The Jellyfish Filter unit shown both closed and open.

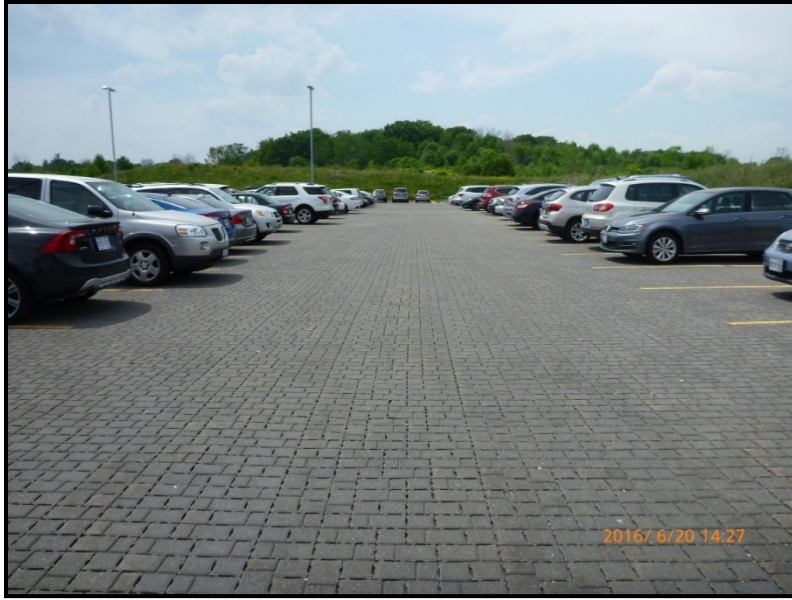
Figure 7: Permeable pavement parking lot at IMAX.

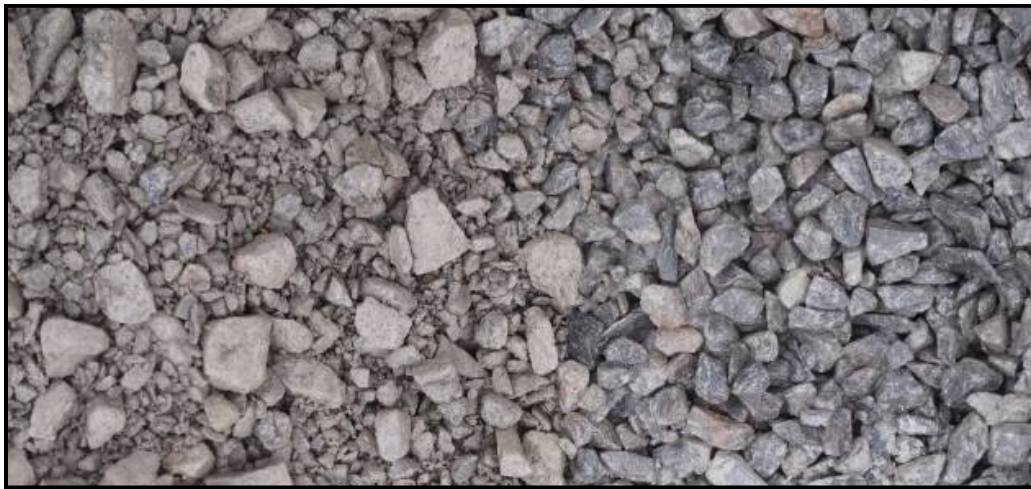
Figure 8: Granular 'O' (left) and 20 mm clearstone (right).

Clearstone is recommended for permeable pavement systems because it does not include fine material and has large void spaces that provide storage for infiltrating stormwater. Without fine material, greater aggregate depth is required to meet structural requirements for traffic loadings. In contrast to clearstone, granular 'O' is readily available in southern Ontario and requires less depth to meet structural requirements, however it contains more fine particles.

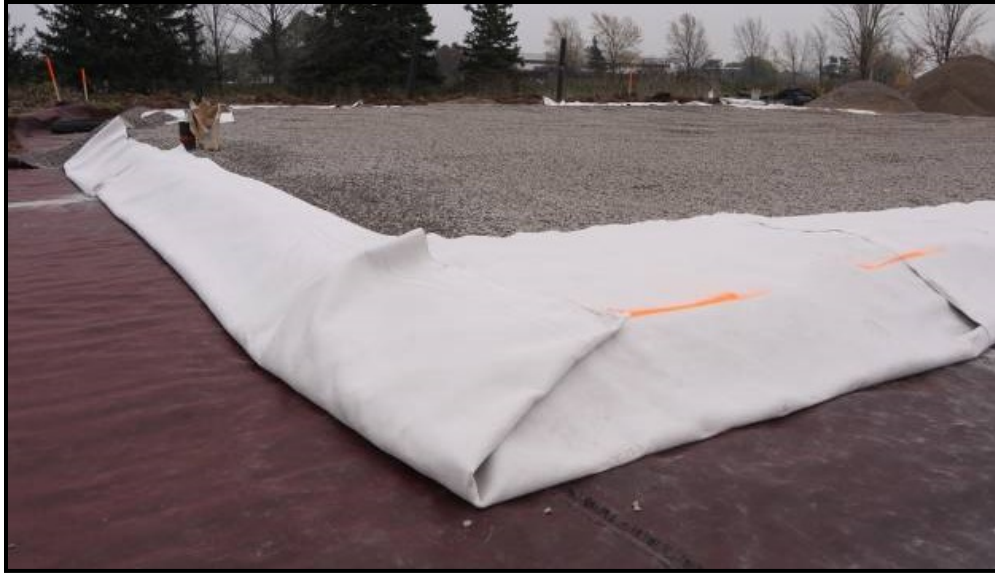
Figure 9: Impermeable geosynthetic clay liner.

As the permeable pavement system was designed with monitoring in mind, a portion of the 20 mm clearstone permeable lot was installed with an impermeable liner at the bottom to prohibit infiltration (Figure 9). This was included to evaluate the potential to provide some of the benefits of LID without posing a risk to groundwater quality. The rest of the permeable pavement lot systems have a geotextile liner at the bottom to allow for infiltration.

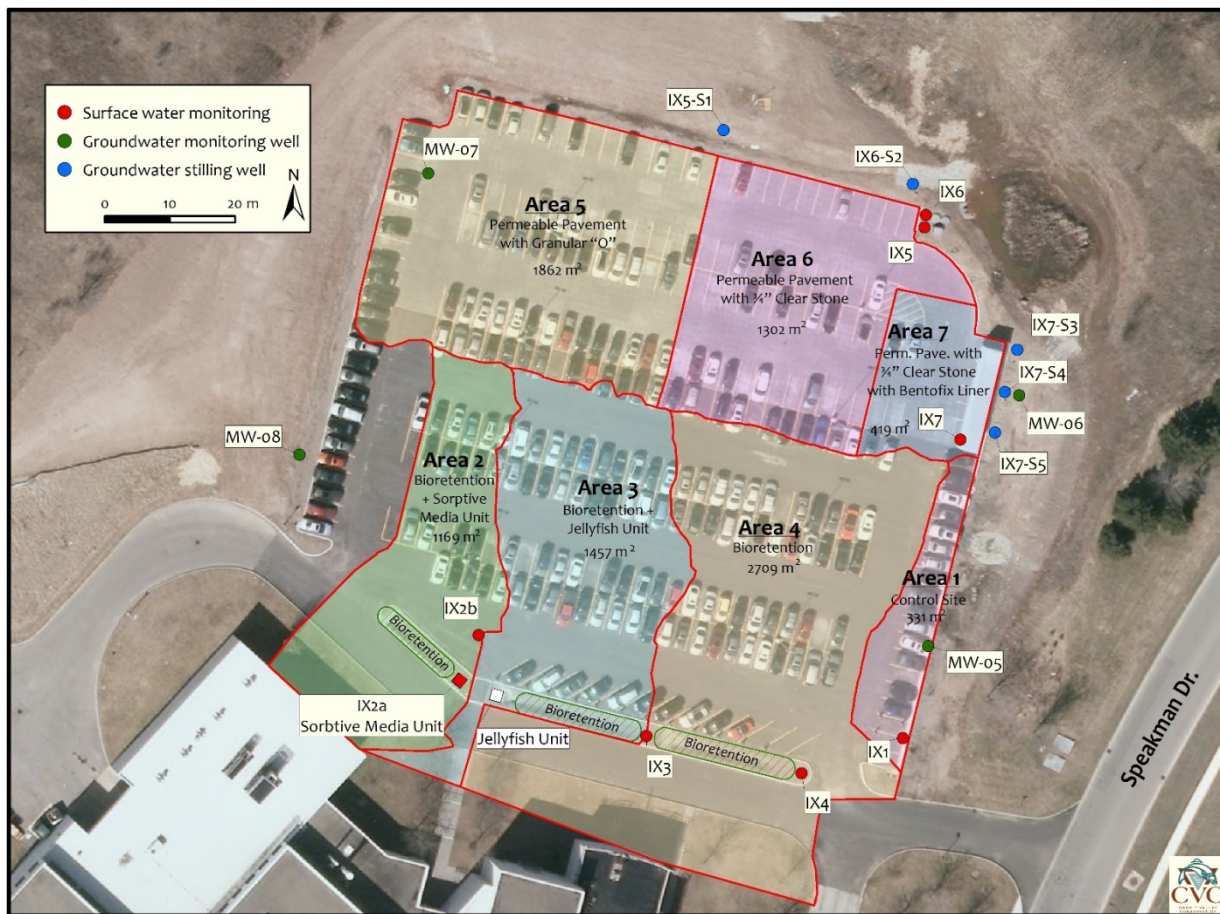
Figure 10: Catchment areas and monitoring stations.

The monitoring program included water quantity and quality monitoring for seven independent catchment areas, groundwater monitoring, and a meteorological station located just north of the parking lot. The catchment areas include the three bioretention swales, three permeable pavement areas, and a control site. A map of the catchment areas and monitoring stations is shown in Figure 10. Areas 2, 3, and 4 drain to the bioretention swales and correspond to monitoring sites IX-2, IX-3, and IX-4, respectively (see Table 3). Areas 5, 6, and 7 are the permeable pavement areas and correspond to monitoring sites IX-5, IX-6, and IX-7, respectively. Area 1 drains to the control site (IX-1). The drainage areas shown are based on as-built surveys and are the ones used for the report. Four groundwater wells were also installed near the four corners of the site, labelled MW-05, MW-06, MW-07, and MW-08. Table 4 summarizes the monitoring at IMAX.

Area 1 in Figure 10 was designated as control site IX-1, with total outflow and water chemistry being monitored from a portion of the parking lot not being treated by LID. However, there were a number of challenges with the monitoring infrastructure at this location. There were consistent leaks in both the concrete structure and weir, leading to issues with the flow data. In addition, changes from the designed drainage area and the as-built drainage area meant that the area was smaller than expected, and consisted of mainly lightly used parking stalls, as they were either portioned off for monitoring access or designated visitor stalls. As a result, this meant that this monitoring location was not representative as a control site. Due to these concerns, data from this site was not used to estimate the chemistry of untreated water at IMAX. Instead, results were used from a similar study using similar methods at the Toronto and Region Conservation Authority (TRCA) Kortright Centre located about 35 km away in Vaughan, Ontario (Van Seters and Drake, 2015).

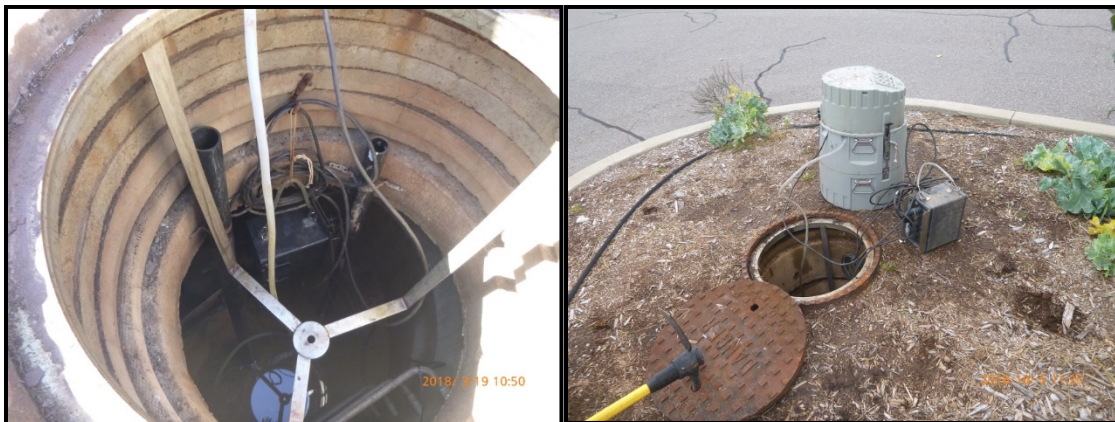
Figure 11: Data logger located within monitoring manhole, the automatic sampler normally sits on the metal basket (left); data logger and automatic sampler removed from monitoring manhole (right).

Dataloggers and automatic samplers were stored either in manholes (e.g. Figure 11) or in above-ground storage boxes. For further details on the sampling methodology and data analysis for both the stormwater and groundwater, see Appendix A.

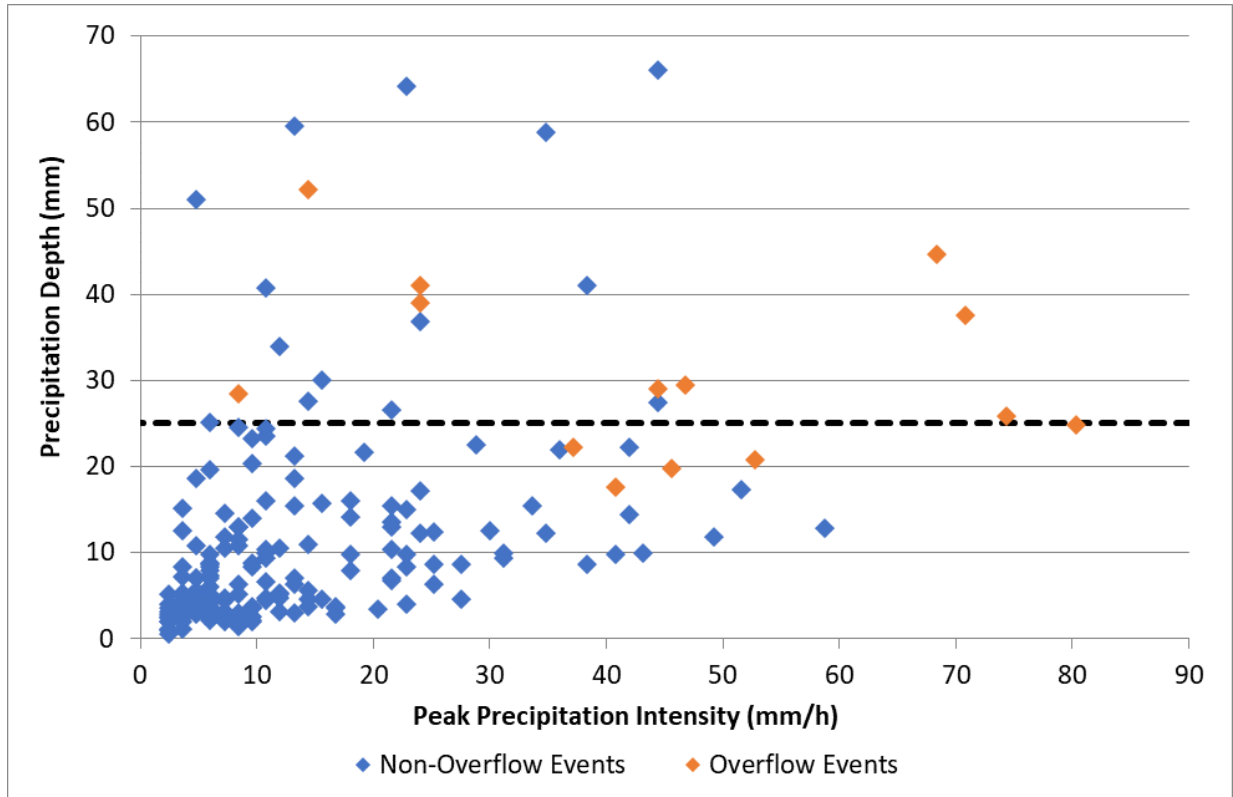
Figure 12: IX-2 overflow and non-overflow events plotted on a precipitation depth vs intensity graph. The dashed line represents 25 mm precipitation depth.

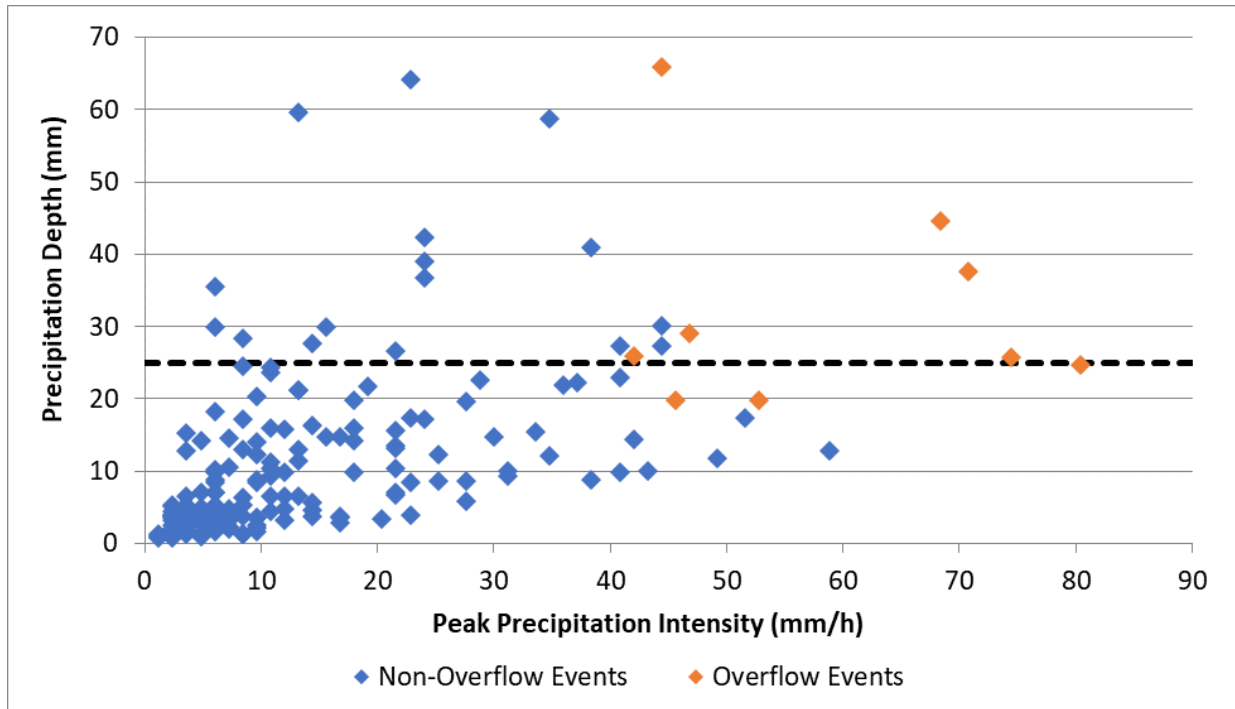
Figure 13: IX-3 overflow and non-overflow events plotted on a precipitation depth vs intensity graph. The dashed line represents 25 mm precipitation depth.

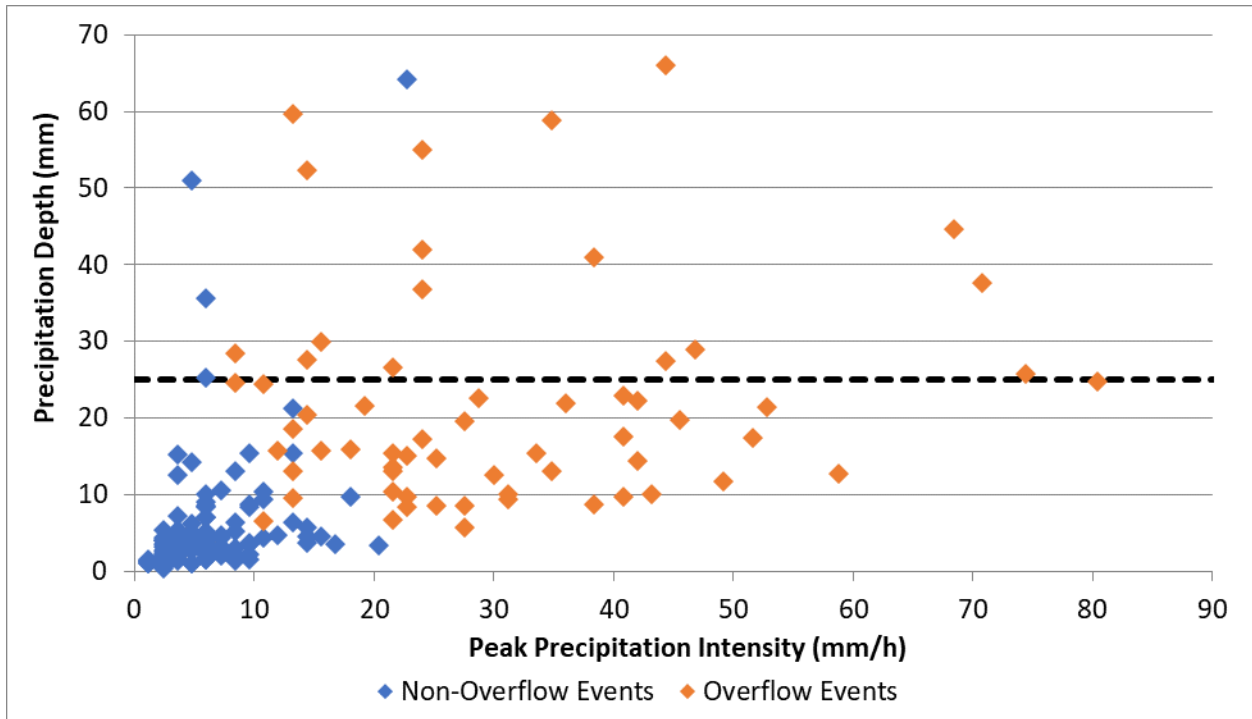
Figure 14: IX-4 overflow and non-overflow events plotted on a precipitation depth vs intensity graph. The dashed line represents 25 mm precipitation depth.

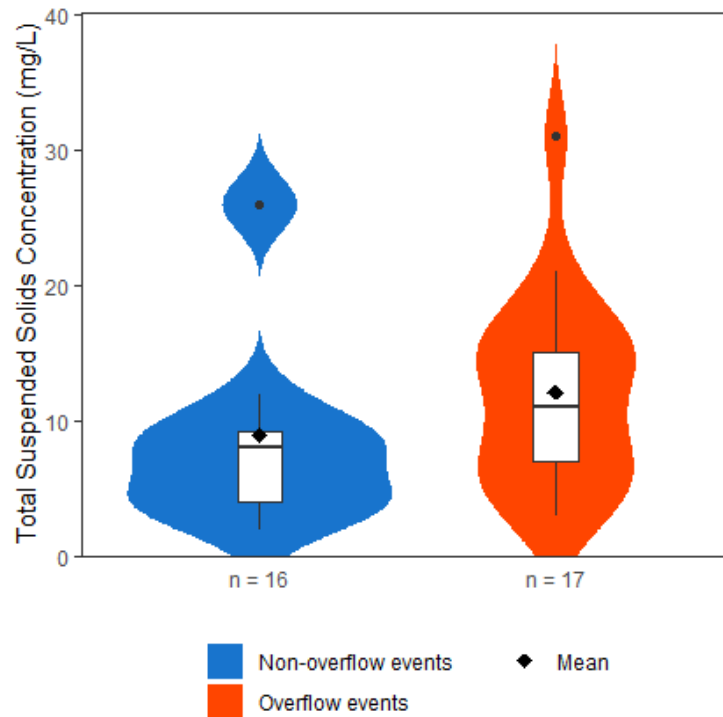
Figure 15: Violin plot of effluent total suspended solids concentrations between overflow and non-overflow events at IX-4.

These results demonstrate that the water quality impact of overflow events can clearly be seen, as even though much of the effluent water is still treated, the overall concentrations of contaminants are still higher. As water entering the overflow is directed to the stormwater system and not infiltrated, these events may also have less infiltration and volume reduction. This would lower the pollutant load reduction, causing the stormwater feature to be less effective at reducing the total mass of the pollutants.

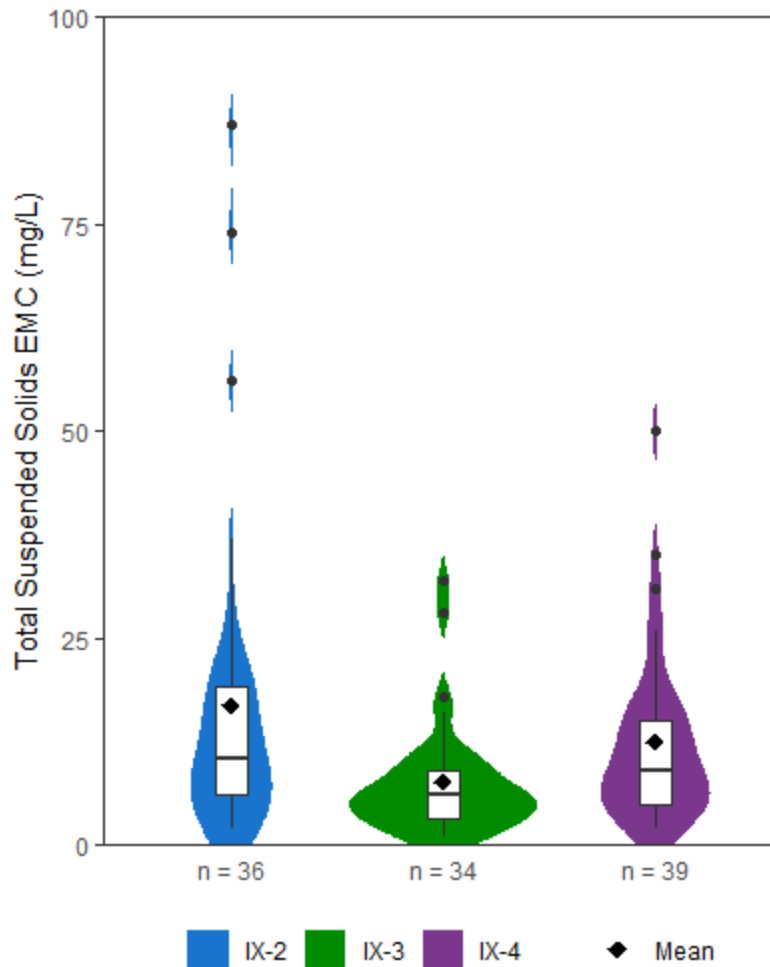
Figure 16: Violin plot of total suspended solids EMCs at IMAX bioretention swales.

The median results indicated a 90% reduction in total suspended solids EMCs, which matches the expected removal efficiency for the Jellyfish Filter of 89% based on performance testing by the manufacturer. This is not a direct comparison, however, as the data from IMAX includes the influence of the bioretention swale and does not consider any load reduction due to infiltration.

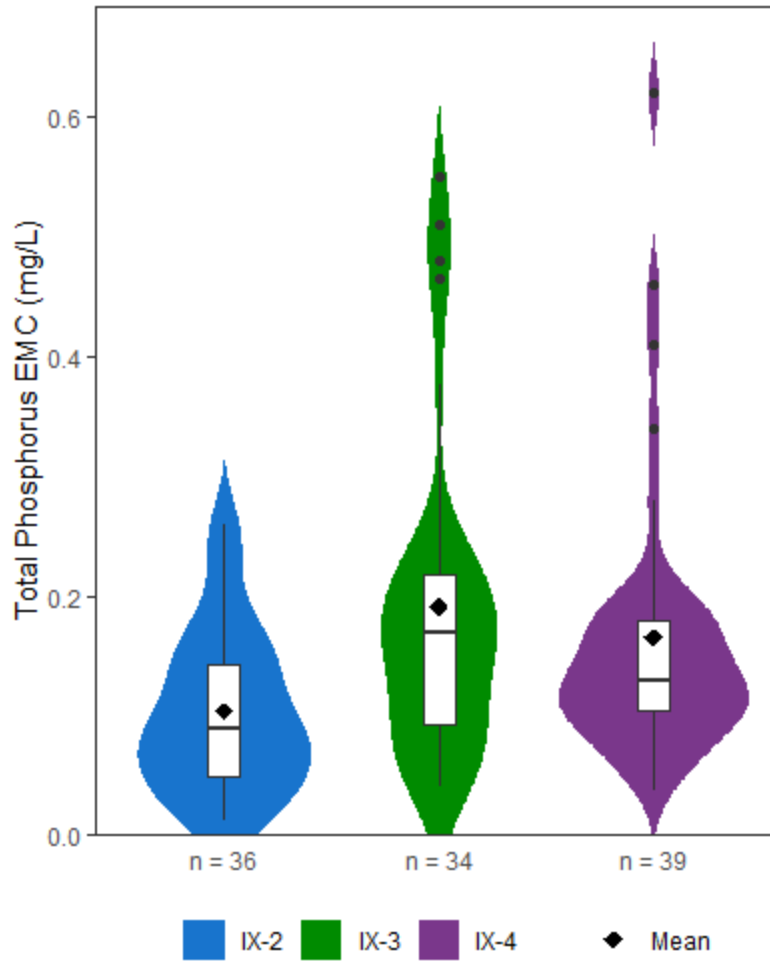
Figure 17: Violin plot of total phosphorus EMCs at IMAX bioretention swales.

Total phosphorus EMCs were all lower than the estimated influent, suggesting that all bioretention features at IMAX lower phosphorus concentrations along with providing runoff volume reduction, and would provide some benefit even if infiltration cannot be achieved. However, the concentrations are still higher than the Provincial Water Quality Objective for avoiding nuisance concentrations of algae in lakes (0.02 mg/L). The results show that the addition of a Sorbtive Media Vault post-treatment is helpful for lowering phosphorus concentrations in stormwater.

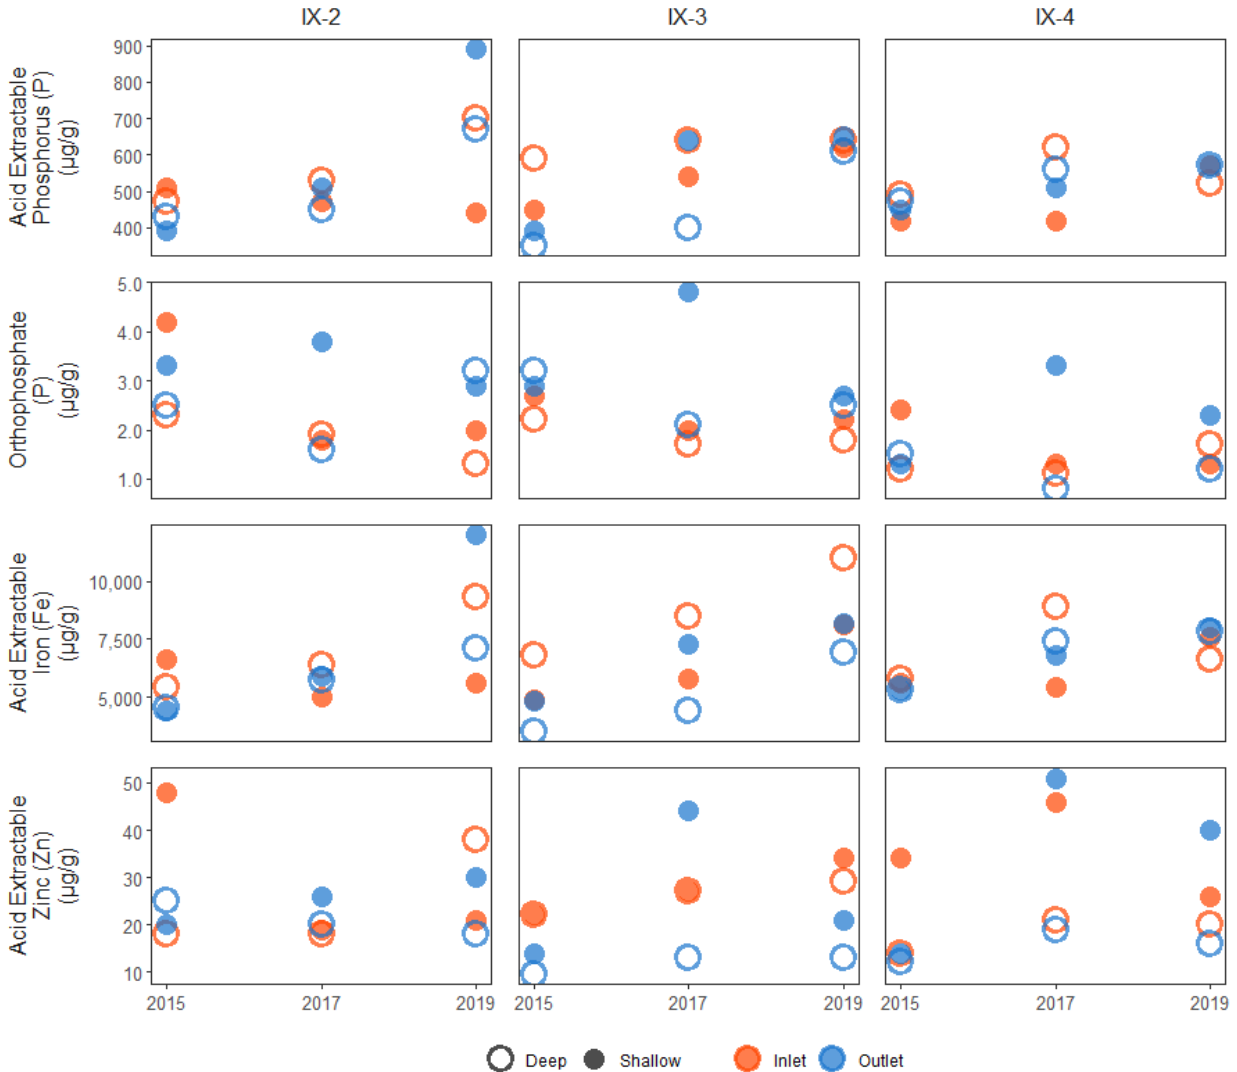
Figure 18: Selected soil sampling results. Note that the shallow inlet, shallow outlet, and deep outlet results are overlapping for the 2019 phosphorus sample at IX-4.

There were no consistent trends from the results of metals across any of the sites in terms of changes over time, depth, and length. Parameters at sites where an increase over time was observed included copper and iron at IX-2 and iron and zinc at IX-3. All cadmium results were under the detection limit. Overall, it does not appear that metals are accumulating in the bioretention swales.

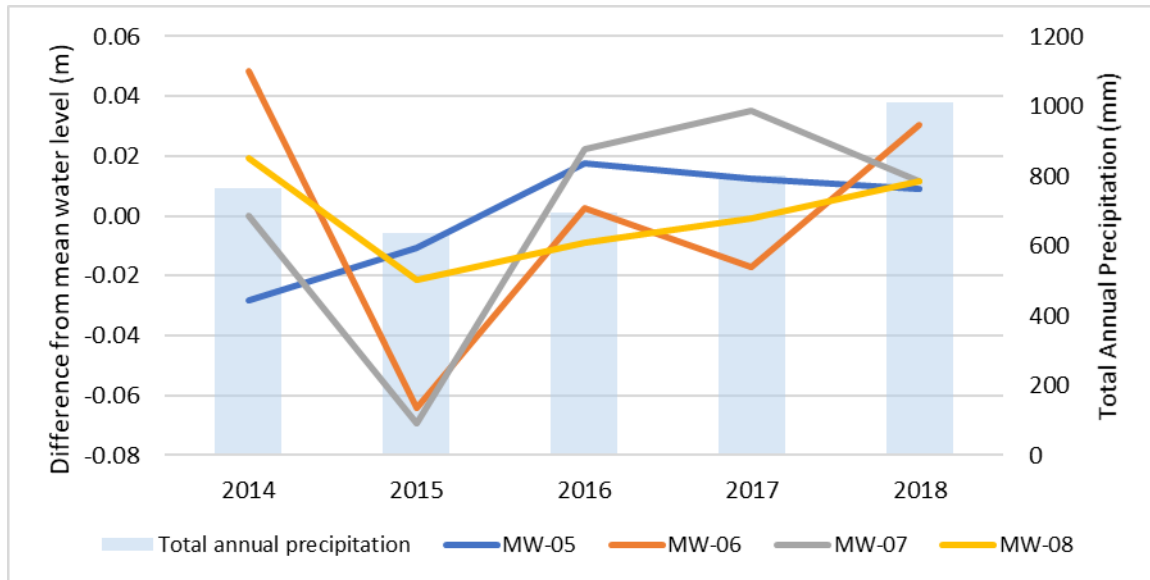
Figure 19: Total annual precipitation and groundwater levels at IMAX. Groundwater levels are shown as the difference between the annual mean and the mean for the entire timeframe.

MW-06, MW-07, and MW-08 all showed a similar seasonal pattern, with higher groundwater levels through the spring months, and the lowest in the late autumn and early winter. This matches the general hydrological pattern in the watershed. While MW-05 did generally have higher levels in the spring than the autumn, the difference was much less pronounced than at the other sites.

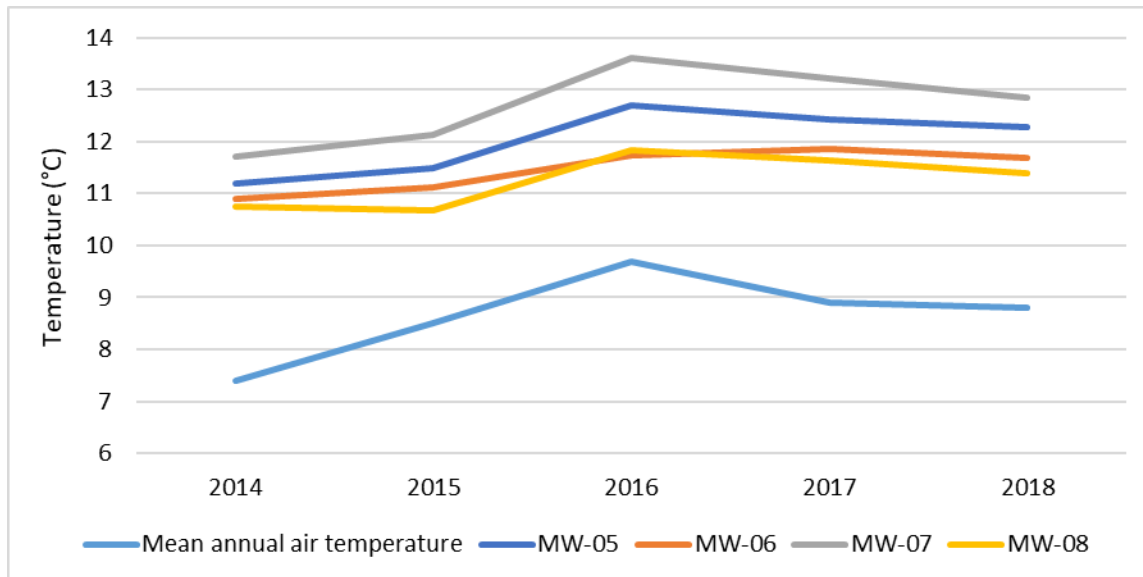
Figure 20: Mean annual temperature for IMAX groundwater wells.

Increased infiltration of stormwater due to LID features may affect the local groundwater temperature. At IMAX, the mean annual water temperature of the groundwater in all wells followed a similar pattern to the mean annual air temperature (Figure 20), with the lowest values in the coldest full year of the study period (2014) and the highest in the warmest year (2016). The two warmest wells (MW-05 and MW-07) are the two installed within the permeable pavement, as opposed to just outside the well. These results may be influenced by thermal exchange with the pavement surface. There is no obvious pattern between the upgradient and downgradient wells, as the two downgradient wells are between the temperatures of the two upgradient wells. Based on these results, it is not apparent if the LID features at IMAX are causing a change over time in groundwater temperatures.

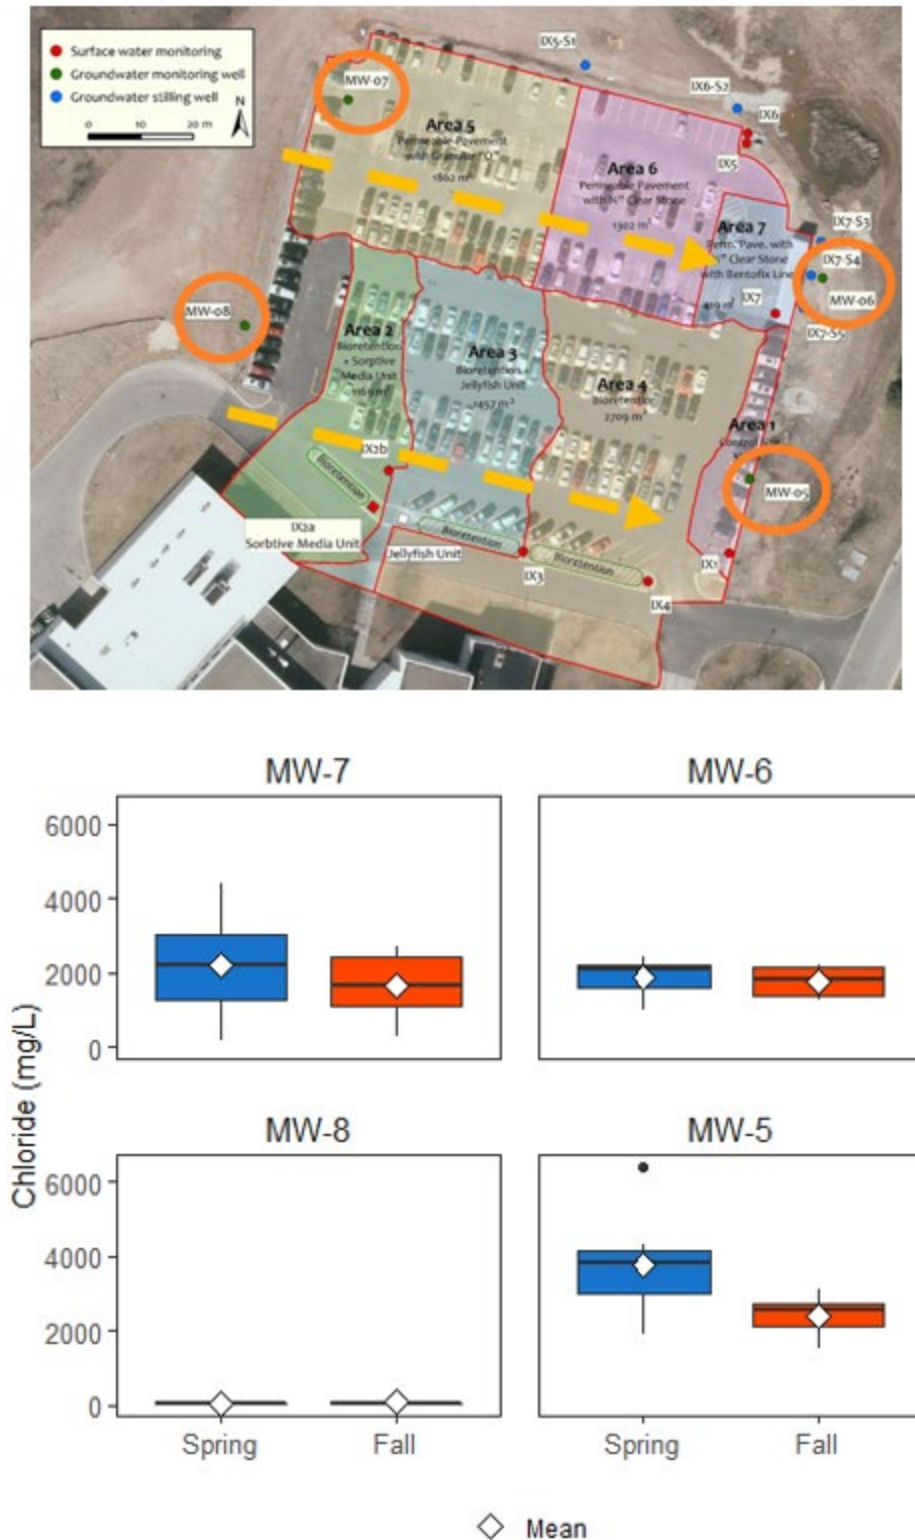
Figure 21: Seasonal chloride concentrations at the four groundwater wells at IMAX, with the map provided for context. Arrows indicate hydraulic gradient.

The two downgradient wells, MW-05 and MW-06, along with MW-07 (upgradient, but located within the permeable parking lot) had much higher chloride concentrations in both spring and autumn than MW-08 (Figure 21). The greatest difference between spring and autumn chloride concentrations was at MW-05, with an over 1000 mg/L difference between the mean value of the two seasons. MW-07 also had higher values in the spring compared to the autumn. There were no seasonal patterns for MW-06 and MW-08.

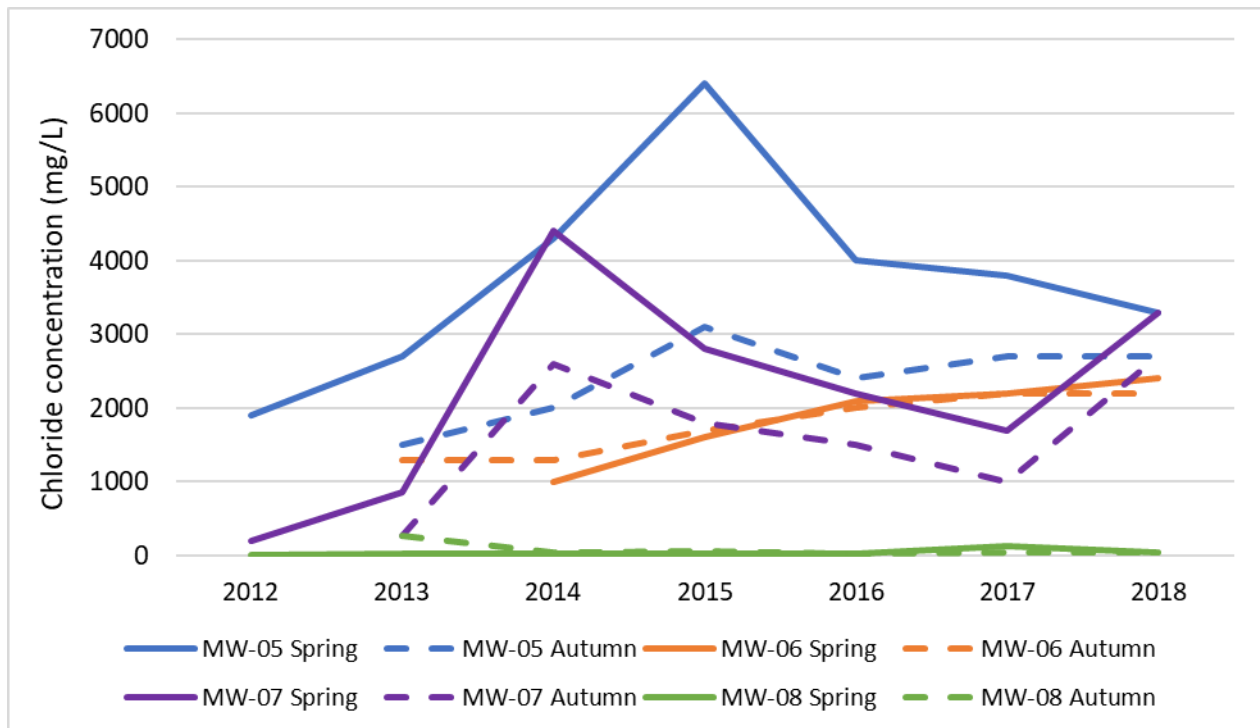
Figure 22: Groundwater chloride concentrations over time at IMAX wells.

These results indicate that it is likely chloride from road runoff is entering the groundwater at the IMAX project site. There is likely a stronger connection at MW-05 and MW-07, at which concentrations are higher in spring and in years with colder winters. While MW-07 is considered upgradient based on the regional groundwater flow, these results indicate it is very likely influenced by the permeable pavement parking lot it is located in. Another possibility is that MW-08 is located in a geologic unit that is hydrogeologically separate from the other wells and thus not representative of upgradient groundwater conditions, however the groundwater level results show that this is unlikely. If groundwater contamination is a concern, properly installed liners should be used to inhibit infiltration.

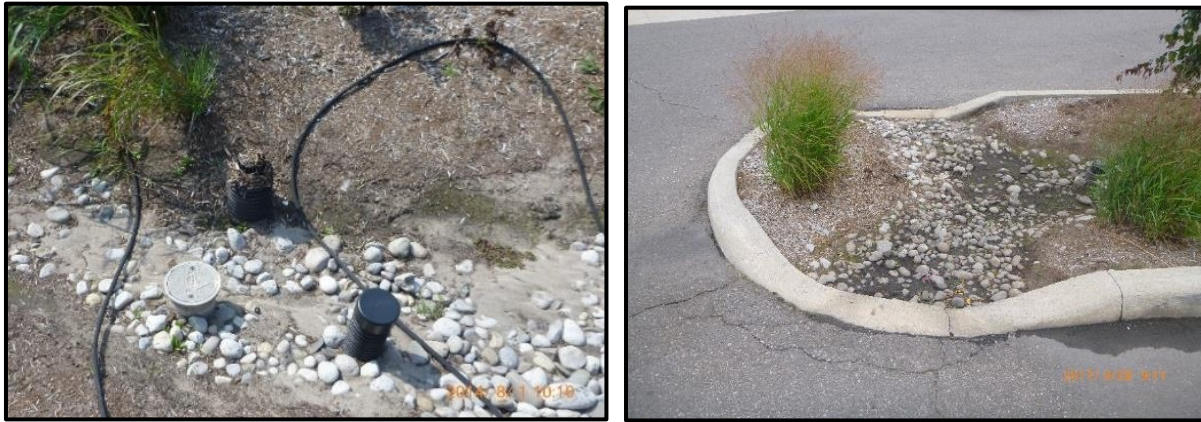
Figure 23: Accumulation of sediment in the centre (left) and inlets (right) of a bioretention swale.

help to focus maintenance activities in the facility and reduce the risk of sediment clogging the entire facility; Figure 23 (right image) shows sediment deposits at two inlets.

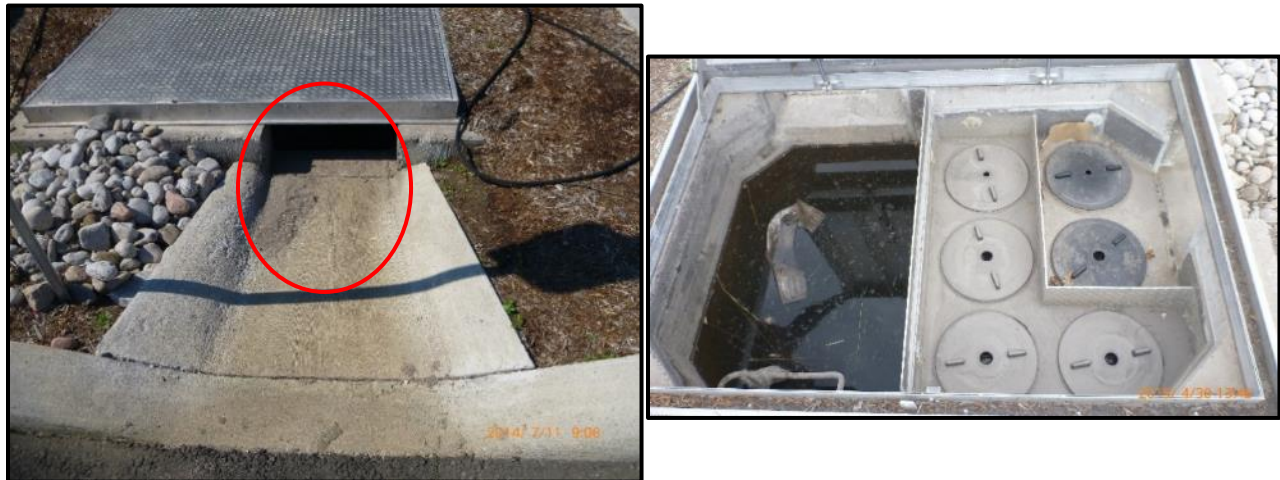
Figure 24: Jellyfish Filter unit pre-treating runoff reducing sediment entering the bioretention swale.

Small deposits of sediment were noted at the inlet spillway into the Jellyfish Filter unit. Few occurrences of sediment in the bioretention swale were documented, indicating the Jellyfish Filters are effective at reducing sediment loading as a pre-treatment device (Figure 24).

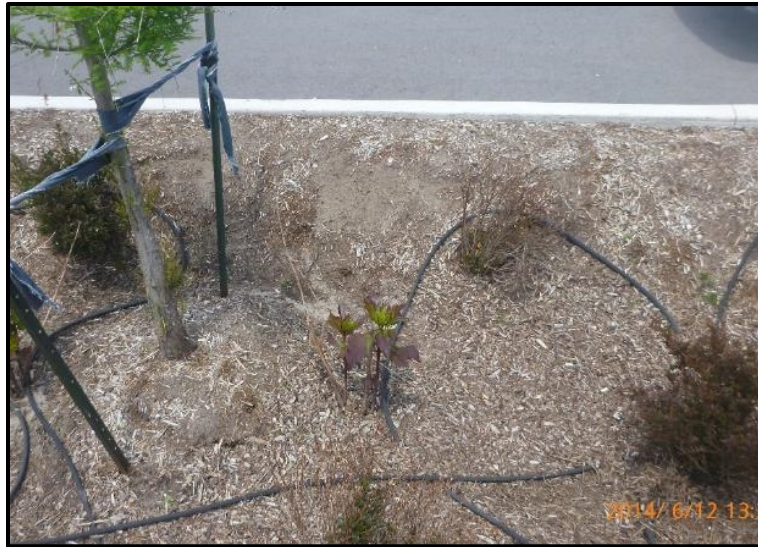
Figure 25: Movement of mulch exposing bare soil.

Site inspections documented an increase in erosion and exposure of bare soil. Mulch was used to enhance visual aesthetics and reduce weed growth in each facility, but it was easily dispersed throughout the bioretention swales during events and carried away into the facility overflows (Figure 25).

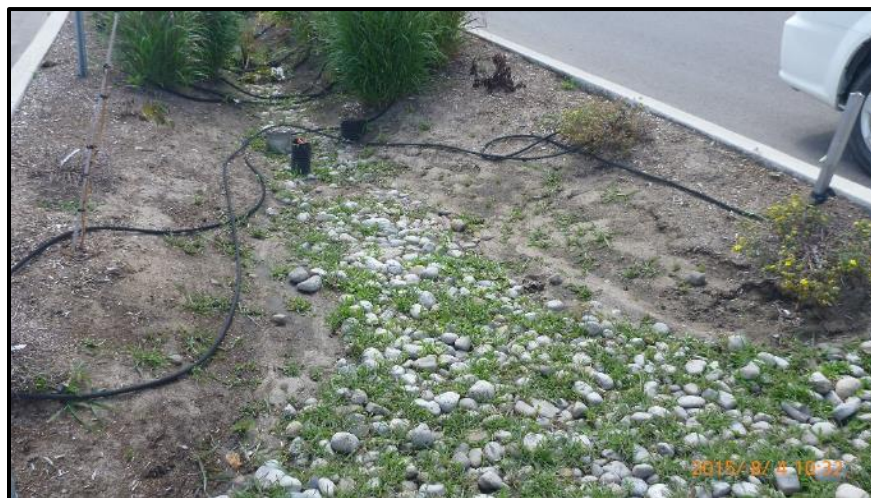
Figure 26: Weeds in the inlet section of a bioretention swale.

After the mulch layer was removed, occurrences of erosion and exposure of bare soil continued in specific areas due to the rate of runoff entering the facilities. Once the vegetation in the bioretention swales became larger and more established, evidence of erosion and bare soil was reduced as the larger plant roots helped to stabilize the soil. The presence of invasive weeds increased slightly after the first two years of monitoring but were then eliminated almost entirely by the end of the monitoring period as the native plants became more established (Figure 26).

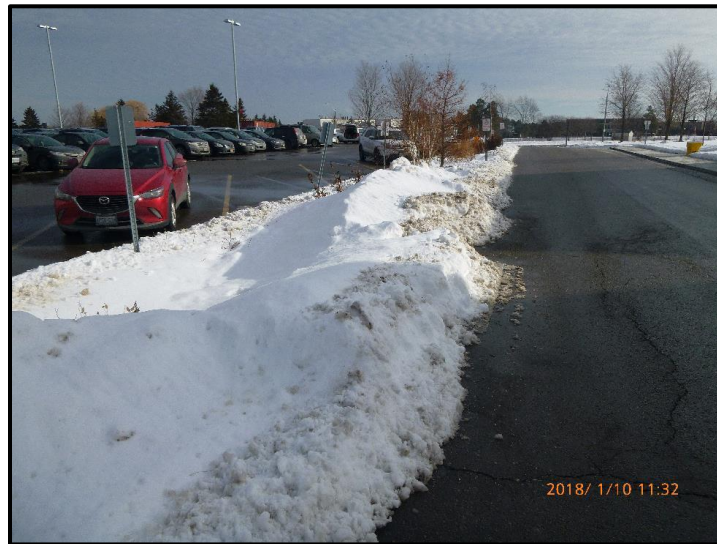
Figure 27: Bioretention swale used for snow storage.

Inspections during winter months observed that the bioretention swales were frequently snow covered and inlets and outlets were blocked with snow (Figure 27). Plowed snow from the parking lot has a specific storage location along the south and north edges of the parking lot and is not typically stored near the bioretention swales. Small amounts of plowed snow are frequently left along the curbed edges of the bioretention swales as the snowplow maneuvers around these facilities. Near the end of the monitoring period, staff observed snow being stored in the bioretention swales. This limits the facility's ability to collect and filter water and may cause ponding on the parking lot from overflow. However, ponding was seldom observed during inspections, suggesting runoff from melt and rain events can still move freely through the facility during winter conditions when natural snow accumulation occurs.

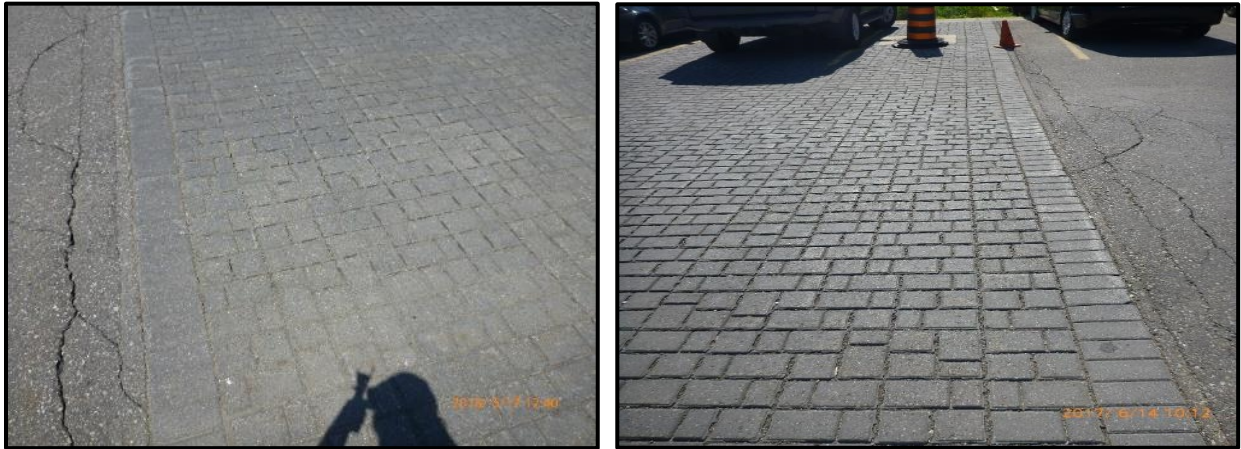
Figure 28: Sediment accumulation in paver joints at the lined facility (left), surface cracks where asphalt meets permeable pavement (right).

joints is anticipated over time as parked cars carry sediment into the parking lot from the roadway in tire treads. Maintenance by a vacuum sweeper can be used to remove this sediment.

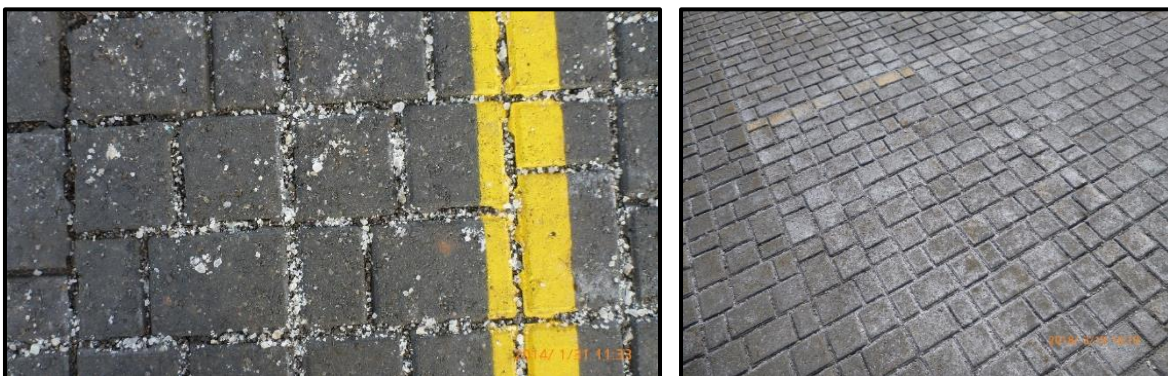
Figure 29: Residual salt within paver joints, and salt staining on the permeable pavement.

Several agencies, including the Region of Peel and the Government of Canada, have provided guidance on the appropriate application of salt for de-icing which should be reviewed to determine the best application load both for ice and sleet management and to limit the impact of salt loading into urban streams. There are many other de-icers that can be applied to the parking lot instead of salt and are often more environmentally friendly. The Sustainable Technologies Evaluation Program (STEP) provides a detailed analysis on alternatives to salt for de-icing as well as cost comparisons, titled [Alternatives to Salt: What else melts snow and ice?](#) (STEP, 2020).
