IMAX Low Impact Development Feature Performance Assessment

Prepared by:
Credit Valley Conservation

February 2022

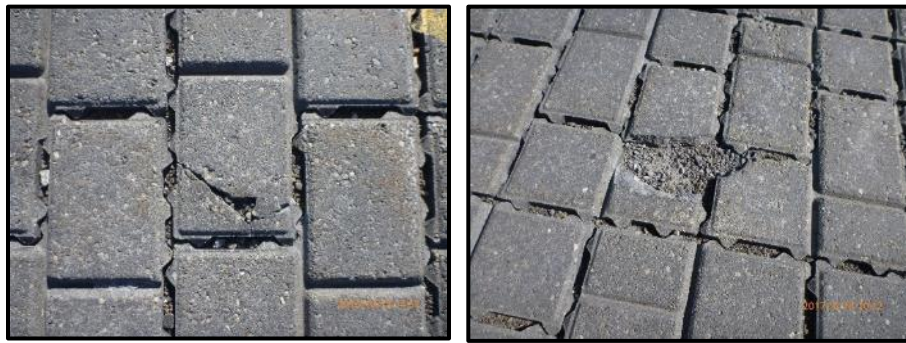
Figure 30: Minor chips in permeable pavers.

Minor chips and paver heaving were observed in small areas across the parking lot in the final year of the monitoring period (Figure 30). Chips and cracks in pavers are common and caused either by age or the freeze-thaw process lifting individual pavers while others may settle. This process is common in winter and early spring and will cause some pavers to be struck by the snowplow blade while snow is being cleared.

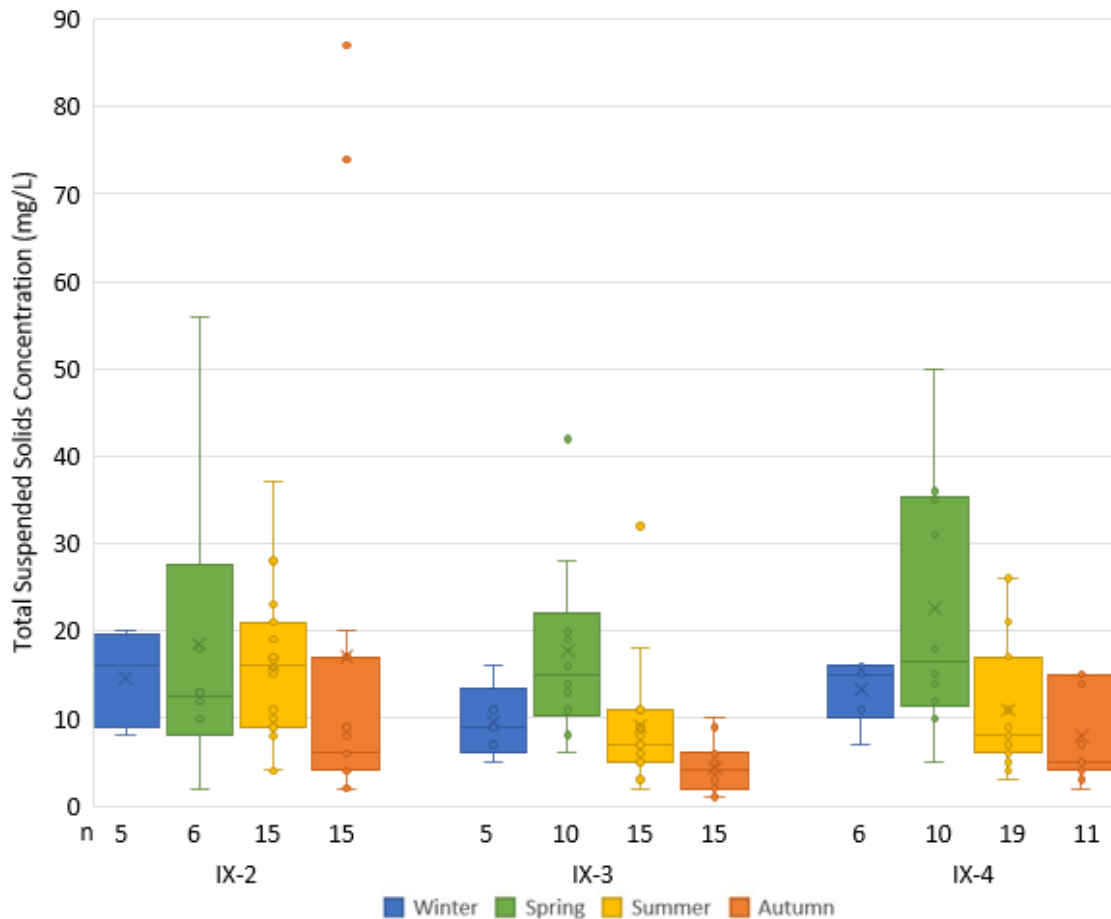
Figure 31: Seasonal box plot of total suspended solids concentrations at IMAX bioretention sites.

Results show that at all sites the highest total suspended solids and total phosphorus concentrations were found in spring and the lowest in autumn (Figure 31 and Figure 32). The autumn results especially show that it is important to not rely on data from only one season when evaluating performance. In the winter and spring, the vegetation in the bioretention swales is not as well established, which may limit filtration of these contaminants. In addition, spring results may include runoff from melting snow, which would collect pollutants throughout the cold weather season. The additional pollutants due to the melting snow may collect on both the parking lot and surface of the swales, slowly being released through the system.

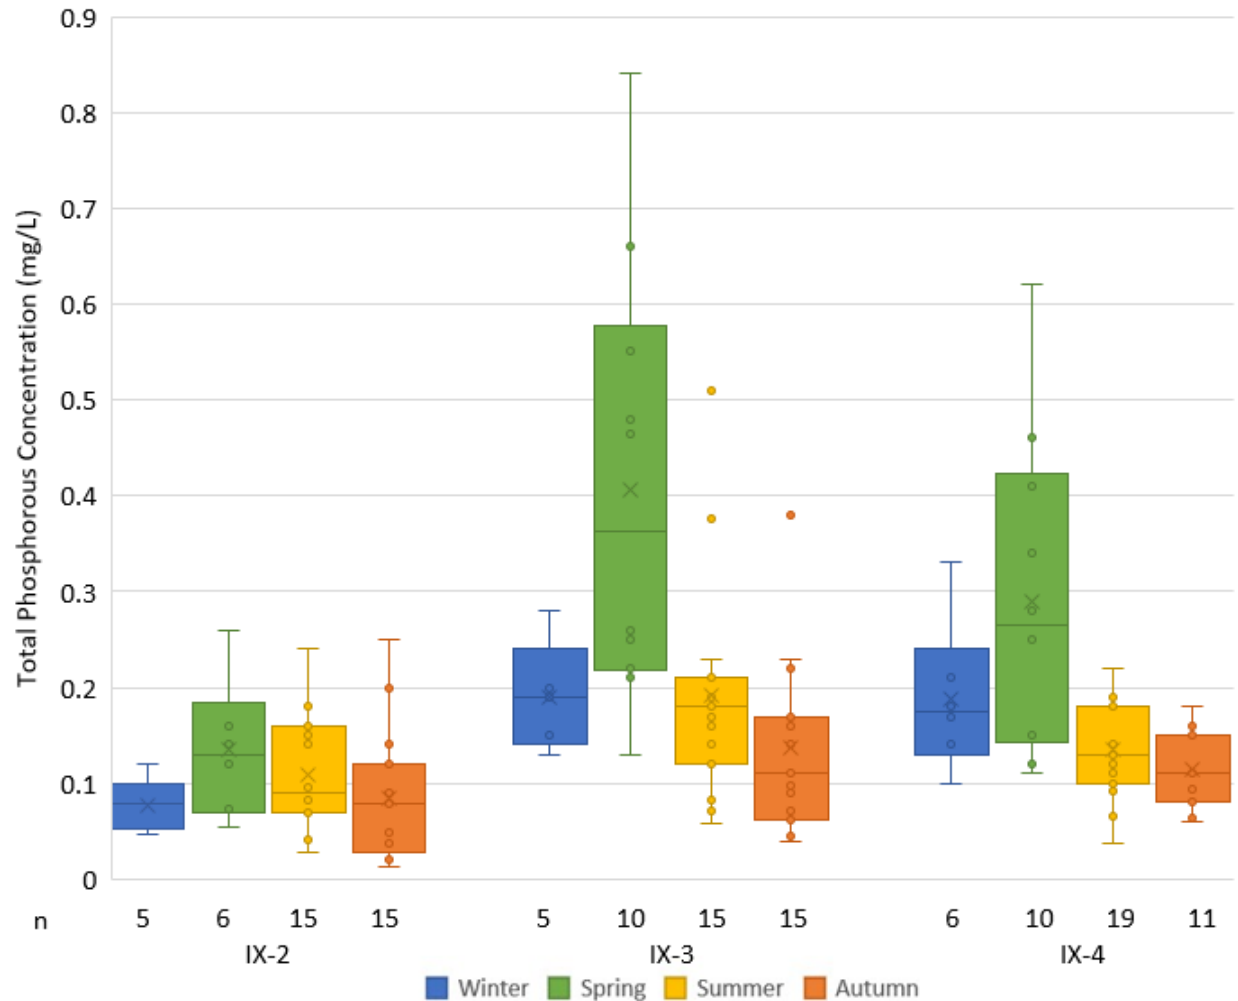
Figure 32: Seasonal box plot of total phosphorus concentrations at IMAX bioretention sites.

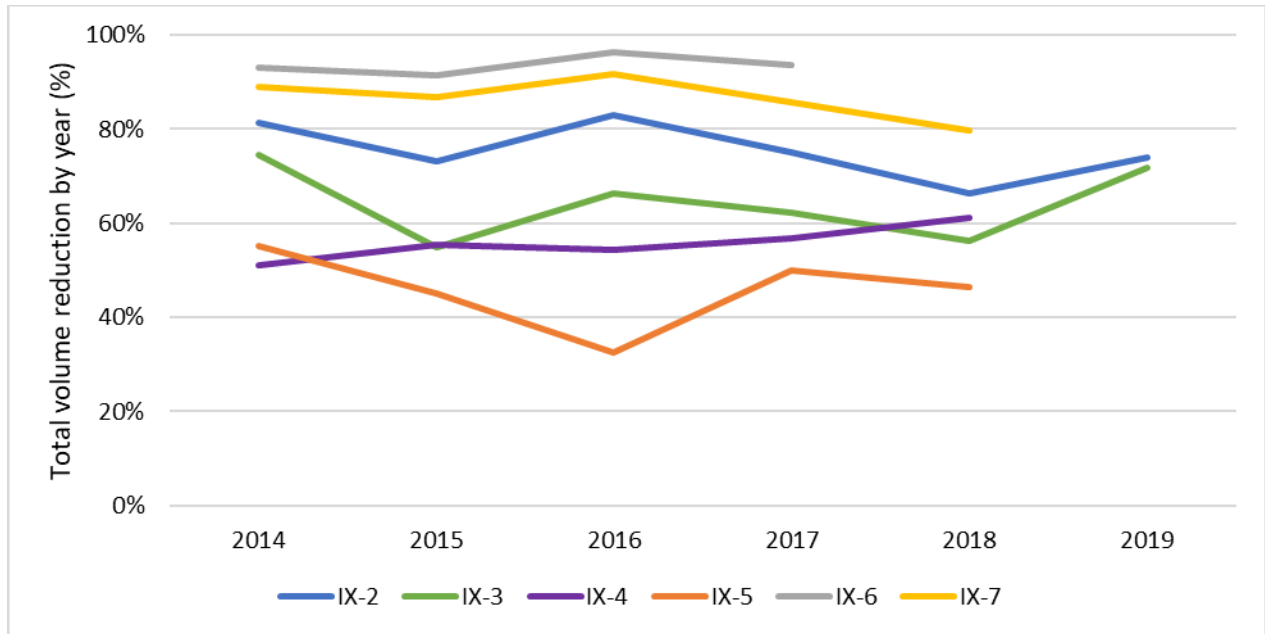
Figure 33: Volume reduction by year for the LID sites at IMAX.

As LID features age, fine sediments may clog the pore spaces and decrease infiltration rates and volume reductions, although this may be mitigated by proper maintenance. The total volume reductions by year are plotted on Figure 33. With the current dataset, the year-to-year variability is masking any long-term change in performance over time. A longer-term dataset is likely needed to show the impact of age on LID features.

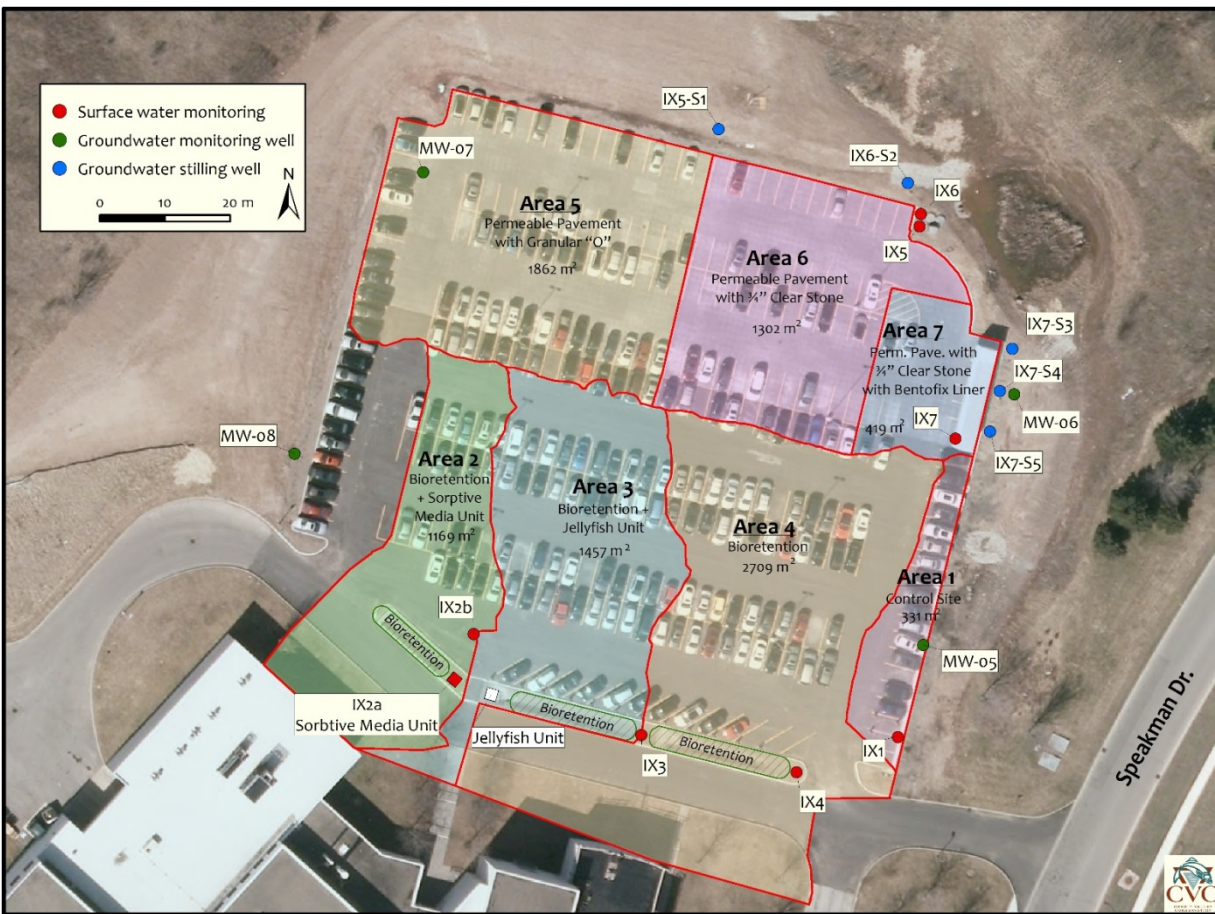
Figure 1: Catchment Areas and monitoring stations. Note: Drainage areas listed for Areas 2, 3 and 4 are the impervious fraction.

The monitoring program included water quantity and quality monitoring for seven different independent catchment areas, groundwater monitoring, and a meteorological station located just north of the parking lot. The catchment areas include the three bioretention swales, three permeable pavement areas, and a control site. A map of the catchment areas and monitoring stations is shown in Figure 1. Areas 2, 3, and 4 drain to the bioretention swales and are monitored at the outlet locations IX-2, IX-3, and IX-4, respectively. Areas 5, 6, and 7 are the permeable pavement areas and are monitored at the outlet locations IX-5, IX-6, and IX-7, respectively. Area 1 drains to the control site (IX-1). The drainage areas shown are based on as-built surveys and are the ones used for the report. Some of the drainage areas changed substantially from the design phase, with the largest increase (+68%) for Area 4. This is suspected to be due to improper grading of the parking lot. Table 1 is a summary of the monitoring for the bioretention swales and Table 2 is a summary of the monitoring for the permeable pavement.

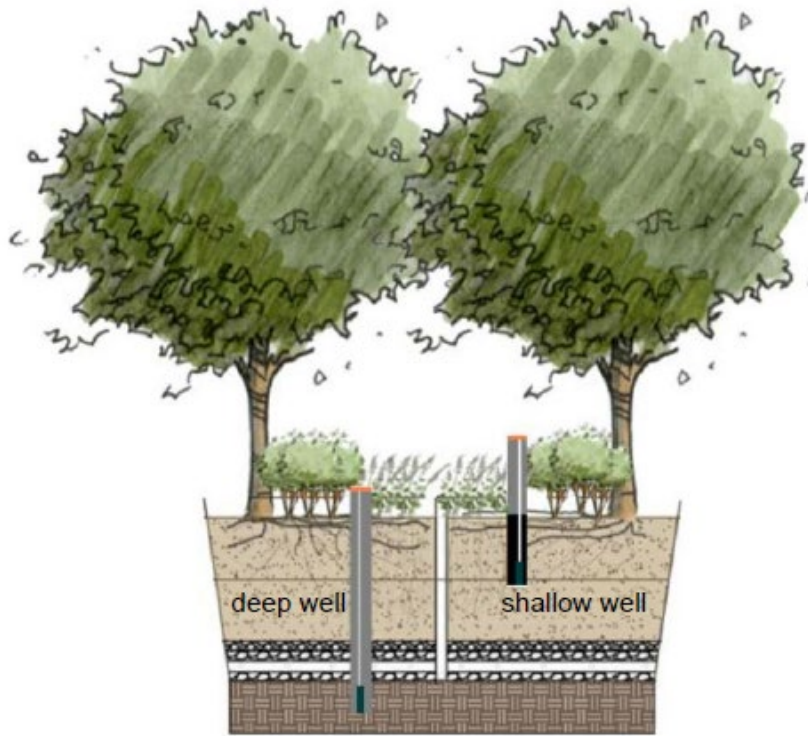
Figure 2: Example figure depicting types of wells used to monitor the bioswales. The deep well in this picture (on the left) measures the water level within the feature, while the shallow well (on the right) measures ponding. Groundwater wells were also used at IMAX.

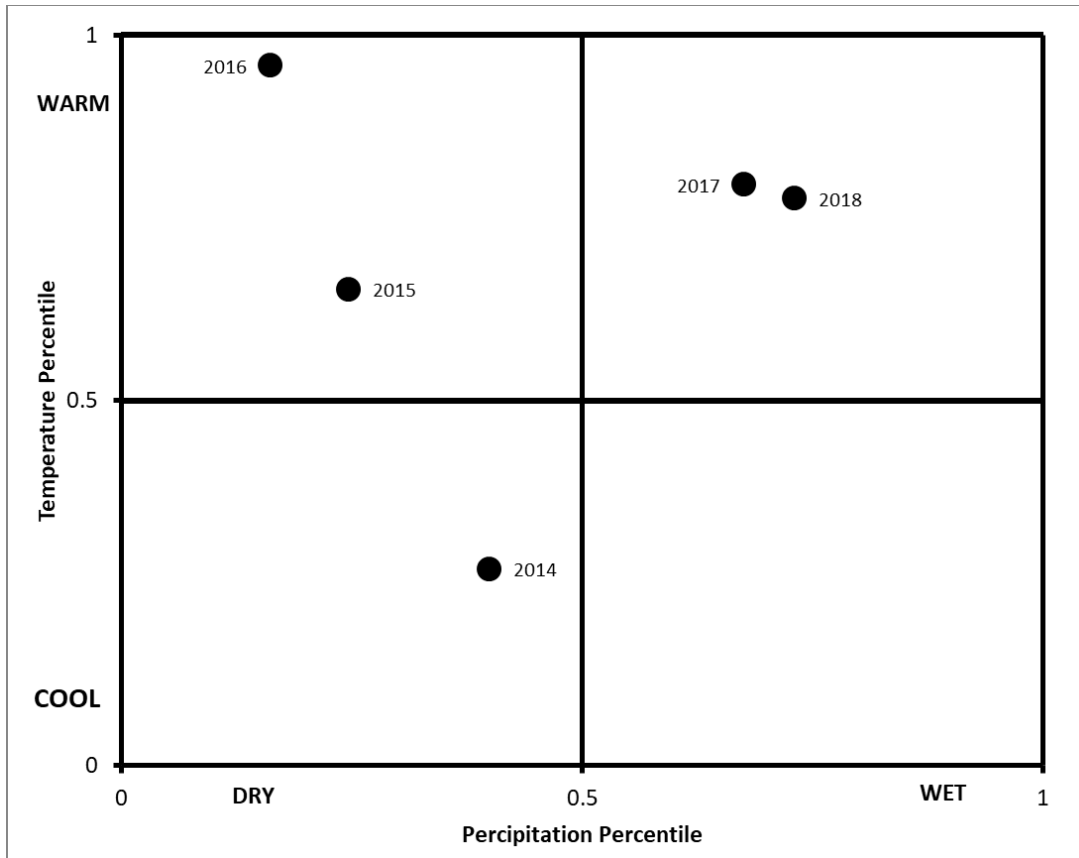
Figure 1: Percentile rank of air temperature and precipitation for the 2014-2018 annual ECCC Toronto Pearson International Airport climate data compared to the 1981-2010 climate normals at the same location.

To see how these values compare to the long term average, the annual precipitation and air temperature values at the ECCC Toronto Pearson station are compared to the 30-year climate normals in Figure 1. Four of the five years during the monitoring period were warm years, with 2016 in the 96th percentile for temperature. Three of the five years were dry years, while two were wet years.
